**MARINE INVESTIGATION REPORT**  
**M12W0207**

**STRIKING OF TERMINAL**

**BULK CARRIER *CAPE APRICOT***  
**ROBERTS BANK, BRITISH COLUMBIA**  
**07 DECEMBER 2012**

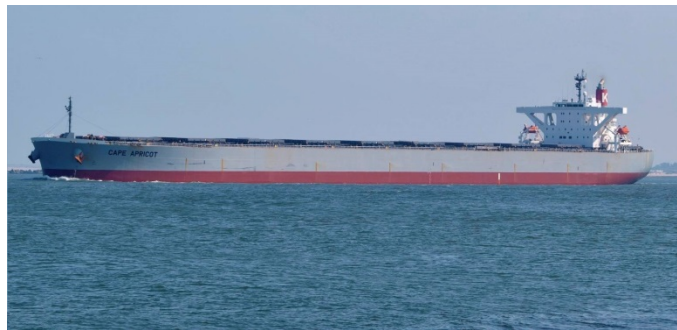
**Photo 1.** *Cape Apricot*

The *Cape Apricot* is a gearless bulk carrier<sup>2</sup> built of steel with the machinery spaces and accommodation aft (see Photo 1 **Error! Reference source not found.**). The vessel has 9 cargo holds and hatches. A bulbous bow encloses the forepeak water ballast tank, and a collision bulkhead segregates the forepeak from the cargo holds. The bridge is equipped with the required navigational equipment,

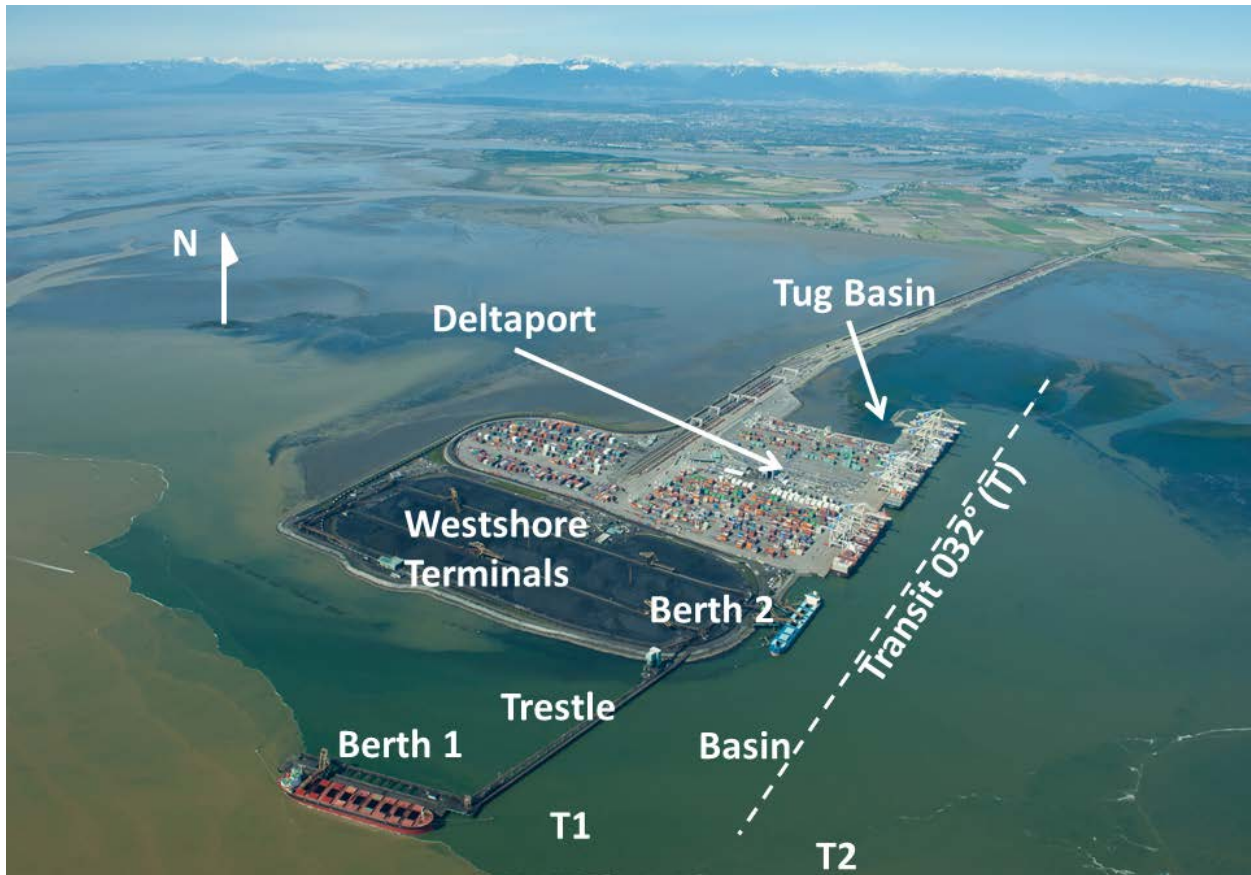
**Photo 2.** Aerial view of Roberts Bank (photo: Westshore Terminals)

Westshore Terminals Limited is a coal export facility located on Roberts Bank, a man-made island (see Photo 2) situated in the Strait of Georgia near the Tsawwassen ferry terminal south of Vancouver, BC. A container facility, known as Deltaport, is also located on Roberts Bank.
