MARINE INVESTIGATION REPORT
M14P0121

SINKING AND LOSS OF LIFE
SMALL FISHING VESSEL *FIVE STAR*
JOHNSTONE STRAIT, BRITISH COLUMBIA
12 JUNE 2014

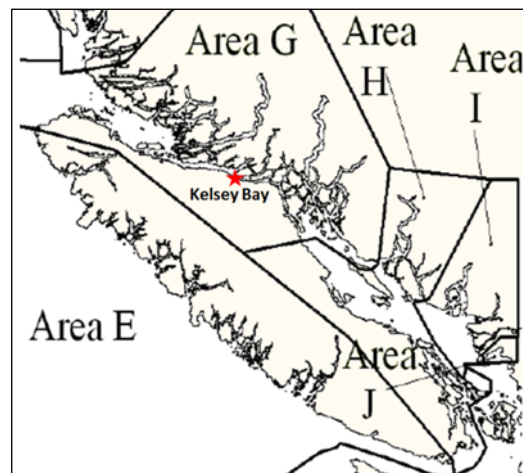
Figure 1. Map of commercial crab management areas (Source: Department of Fisheries and Oceans 2014 Crab Integrated Fisheries Management Plan, Appendix 7.1, with TSB annotations)

On 10 June 2014, the master of the *Five Star* and 1 crew member departed Kelsey Bay, British Columbia, on a crab fishing voyage within the Department of Fisheries and Oceans (DFO) crab management Area G⁴ (Figure 1). On 12 June, after 3 days of crabbing, the *Five Star* departed the grounds at approximately 1400,⁵ bound for Kelsey Bay with a catch of crabs estimated at 1250 kg.⁶ The crabs were dispersed in 22 holding cages⁷ stowed on the working deck.
