**MARINE INVESTIGATION REPORT
M15A0045**

PERSON OVERBOARD AND SUBSEQUENT LOSS OF LIFE

**SMALL FISHING VESSEL *FOUR LADIES* 2003
15 NAUTICAL MILES SOUTH OF CAPE SABLE ISLAND,
NOVA SCOTIA
09 MARCH 2015**

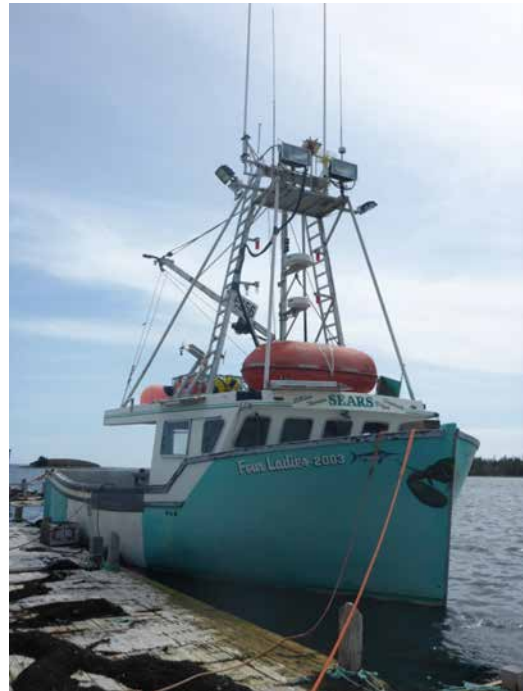
Photo 1. *Four Ladies 2003*

The *Four Ladies 2003* is a small open-construction fishing vessel of the Cape Island design, built from moulded, glass-reinforced plastic. The wheelhouse and accommodation are located forward of amidships, and the engine room is situated beneath the wheelhouse (Photo 1). The wheelhouse can be accessed via doors on its starboard and aft sides. Access to the engine room is through a covered hatch located in the wheelhouse.
