**MARINE INVESTIGATION REPORT**  
**M15P0037**

**SINKING**

**TUG SYRINGA**  
**OFF SEHEL T, BRITISH COLUMBIA**  
**18 MARCH 2015**

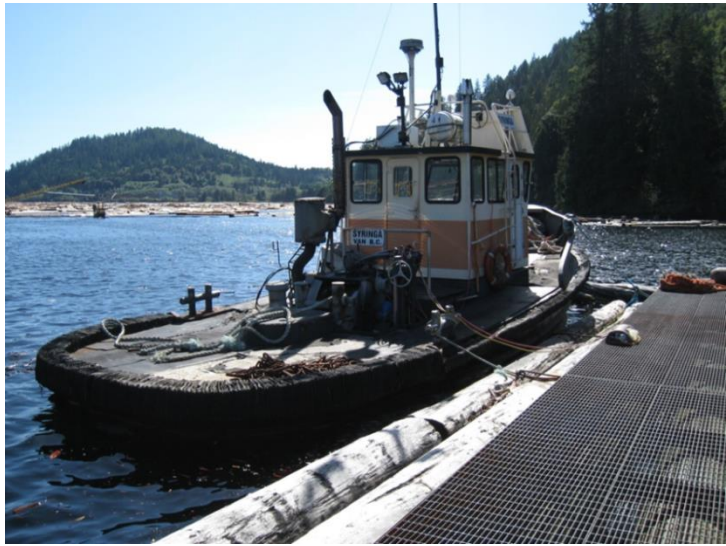
Photo 1. *Syringa*

The *Syringa* is a single-screw, steel-hulled tug of closed construction built in 1960. It has a plumb stem<sup>1</sup> and rounded transom stern (Photo 1). A small aluminium wheelhouse is located on the fore part of the main deck, which is flush with no bulwark aft of the wheelhouse. The hull below the main deck is subdivided by 3 transverse bulkheads that enclose 3 compartments (from forward): the crew accommodation space, the engine room, and the lazarette.

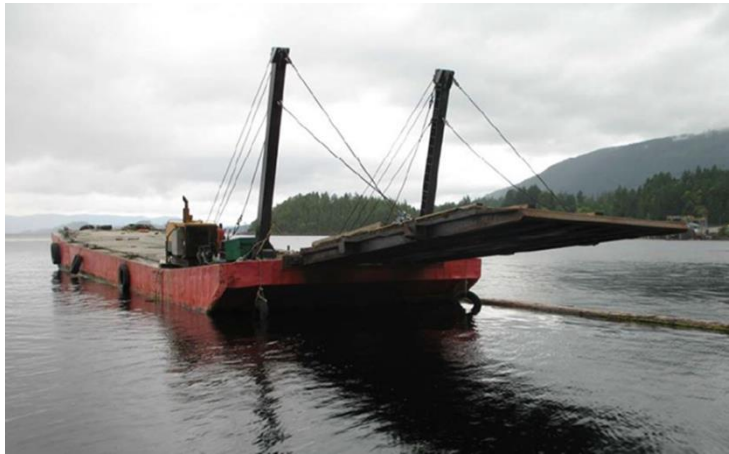
Photo 2. *Matcon 1*

The *Matcon 1* is a steel barge with a flush concrete deck (Photo 2). The barge is registered under the name *Matcon 1*, but the owners also refer to it as the *Jessie Ann* and it has this name painted on the hull. The barge has a fore-and-aft centre bulkhead and is divided into 8 compartments. The cargo ramp, located forward, is controlled by hydraulically driven winches. Power for the hydraulics is supplied by a portable 4-cylinder diesel engine that drives the hydraulic pump.
