MARINE INVESTIGATION REPORT

M16P0241

Fire and abandonment

Tug Ken Mackenzie

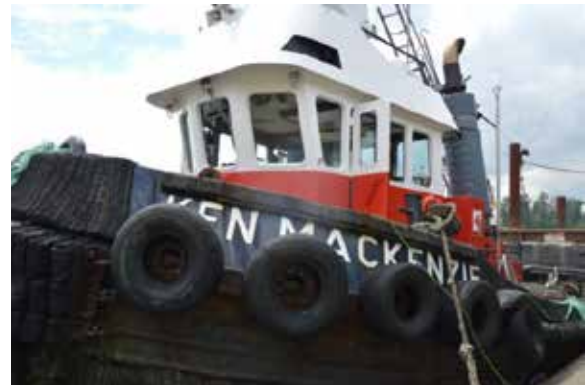
Figure 1. Tug *Ken Mackenzie*

The *Ken Mackenzie* (Figure 1) is a twin-screw, carvel/flush full displacement steel-hulled tug built in 1989. A small aluminum wheelhouse is located on the fore part of the main deck, and is bolted to the main steel base that is raised above the main deck. The wheelhouse is accessible from the main deck, on its port and starboard sides, through watertight doors. The wheelhouse is fitted with a centre steering console, propulsion controls, and navigation equipment consisting of 2 very high frequency (VHF) radiotelephones with digital selective calling, a radar, a magnetic compass, an autopilot, a global positioning system (GPS), an automatic identification system (AIS)¹, and an echo sounder. A galley containing a compact oven, a fridge, a microwave, and a settee is located aft of the helm station.
