# Marine Transportation Safety Investigation Report M19C0387

## BOTTOM CONTACT

Bulk carrier *Kaministiquia*  
Kahnawake, Quebec  
27 November 2019

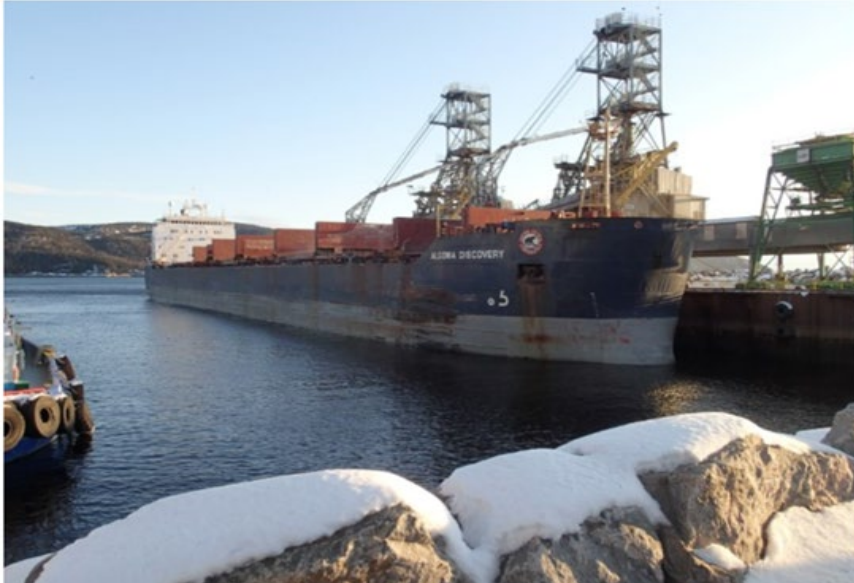
**Figure 2. The bulk carrier *Algoma Discovery*, secured alongside the Cargill grain terminal in Baie-Comeau, Quebec (Source: TSB)**

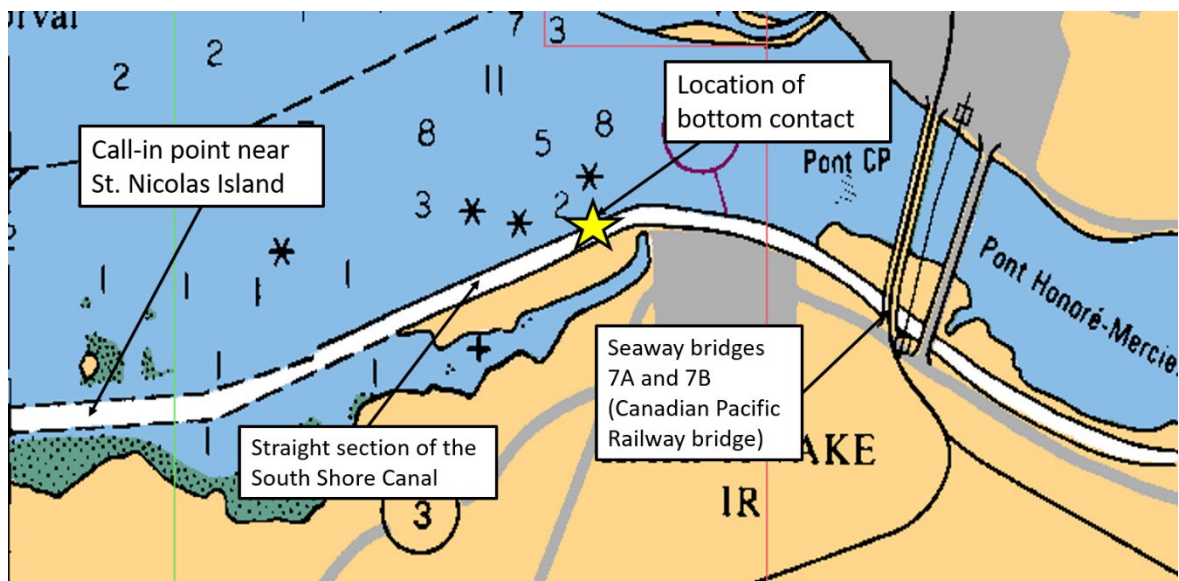
Figure 3. Image depicting the occurrence location (Source: Canadian Hydrographic Services, Chart No. 1409, with TSB annotations)
