MARINE TRANSPORTATION SAFETY INVESTIGATION REPORT M20A0434

SINKING WITH LOSS OF LIFE

Fishing vessel *Chief William Saulis*
12 nautical miles NNE of Digby, Nova Scotia
15 December 2020

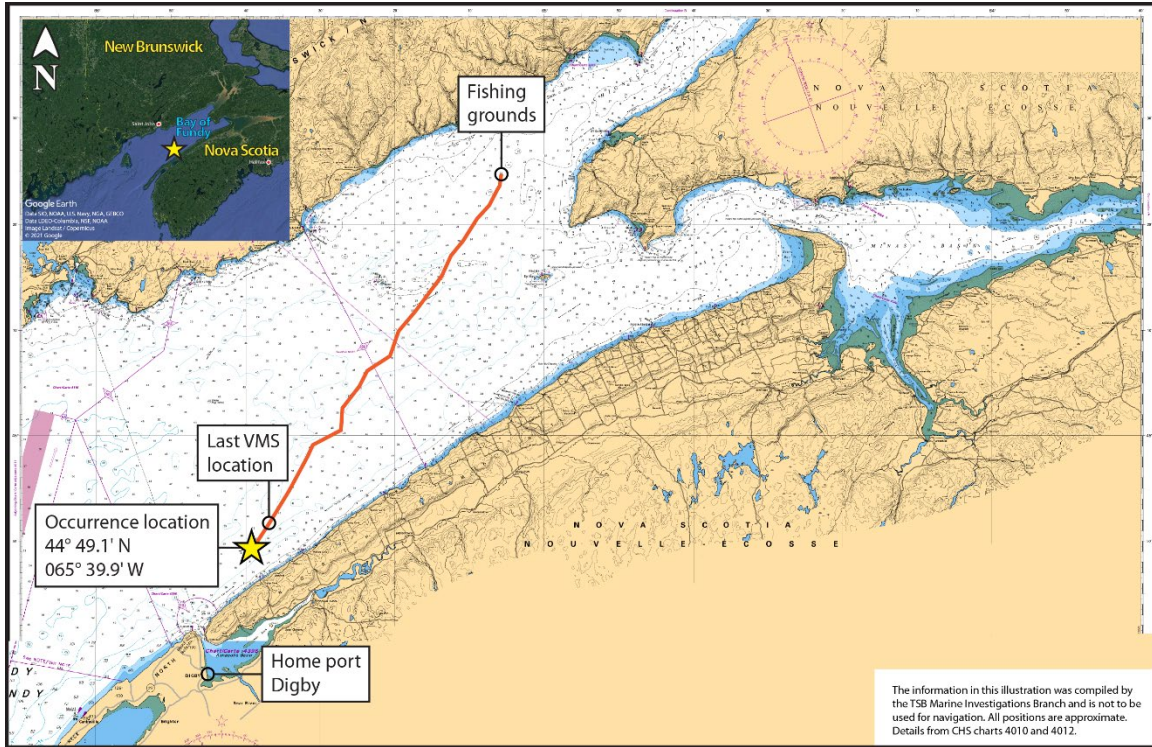
Figure 3. Area of the occurrence, showing the fishing grounds and the position of the last VMS signal (Source of main image: Canadian Hydrographic Service charts 4010 and 4012, with TSB annotations. Source of inset image: Google Earth, with TSB annotations)

On 15 December, just after midnight, the *Chief William Saulis* departed the fishing grounds. They were near the end of a typical trip,⁶ and the last weather forecast at 2000 indicated a gale warning and winds increasing from 10 to 15 knots up to 35 knots by early morning.⁷ They proceeded on a southwesterly course to return to Digby, finish shucking, and offload the scallops. Another scallop fishing vessel, the *Brier Endeavor*, had departed the fishing grounds just before the *Chief William Saulis*. The *Brier Endeavor* slowed down on the trip home because of the environmental conditions. At 0300, the *Chief William Saulis*'s VMS showed it had reduced speed to 6.5 knots from 8.6 knots.

At 0500, when the last VMS position was received,⁸ the vessel's heading was 195° magnetic and the speed had been further reduced to 5.4 knots. At 0551, the vessel's EPIRB activated approximately 3.4 NM south-southwest from the last VMS position. In response, search and rescue coordinators at the Joint Rescue Coordination Centre (JRCC) in Halifax retrieved the
