# MARINE TRANSPORTATION SAFETY INVESTIGATION REPORT M20C0188

## **COLLISION**

General cargo vessels *Florence Spirit* and *Alanis*  
Welland Canal, Ontario  
11 July 2020

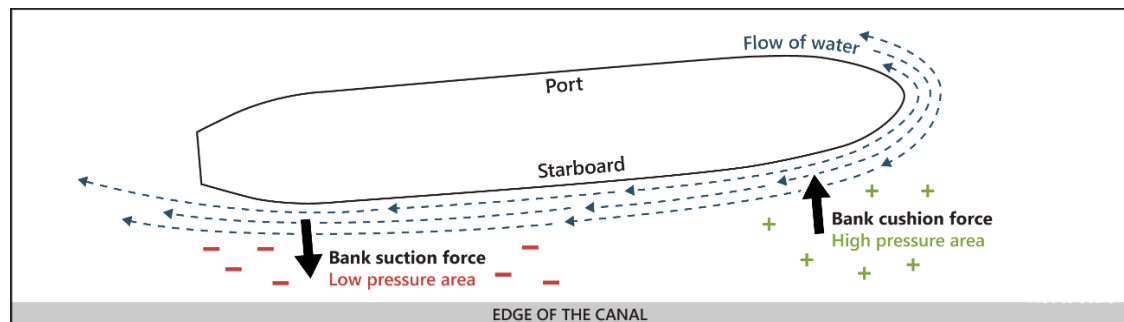
Figure 11. Diagram illustrating bank effect (Source: TSB)

Bank effect is generated primarily by 2 forces: bank cushion and bank suction (Figure 11). Bank cushion affects the vessel's bow. As the vessel gets closer to the bank of a channel, the bow wave pushes against the bank and creates a cushion that forces the bow away from the bank and produces a yawing movement. The water from the bow wave is then squeezed between the hull and the bank as the vessel proceeds, flowing faster on the side of the vessel that is closer to the bank and making the forces around the vessel asymmetrical. This causes a low pressure area to develop further aft, which results in bank suction at the vessel's stern. This tends to pull the stern toward the bank, which also produces a yawing movement. The combination of the bow pushing away from the bank and the stern pulling toward it creates the potential for the vessel to sheer abruptly toward midchannel.<sup>23,24</sup>
