MARINE TRANSPORTATION SAFETY INVESTIGATION REPORT M20P0230

BATTERY EXPLOSION

*Tug *Risco Warrior**
Bute Inlet, British Columbia
07 August 2020

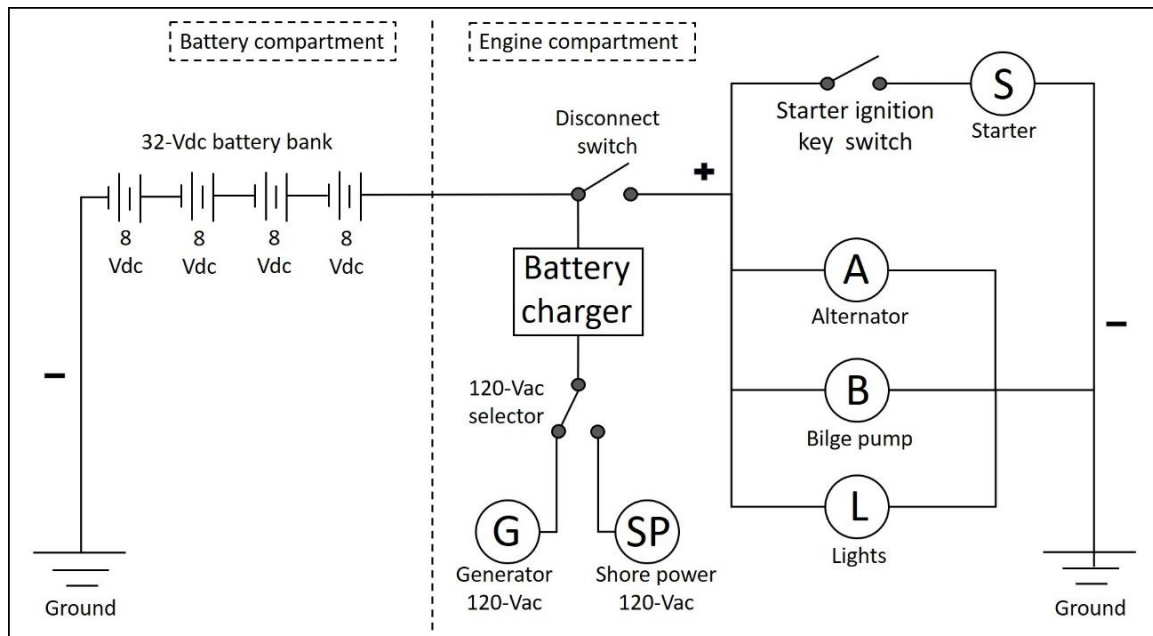
Figure 8. Power distribution diagram for the 32-VDC battery bank, showing how the charging of the battery bank can be transferred between generator and shore power (Source: TSB, based on diagram from Glory Days Towing Ltd.)

The 32-VDC battery bank powered the port and starboard main engine starters, the bilge pumps for the battery compartment and engine room, 2 spotlights, and all of the engine room lights (Figure 8).

When the vessel engines were not running and the disconnect switch was engaged, the 32-VDC battery bank provided voltage to the engine room lights, bilge pumps, and the starboard engine starter, when required. The 32-VDC battery bank was charged through a direct connection from a 120-volt alternating current (VAC) battery charger, which

The 2nd means of charging was through the starboard engine 32-VDC alternator, which fed directly through a disconnect switch to the battery bank (Figure 8). The disconnect switch was used to electrically disconnect the path between the alternator and other equipment to the battery bank for maintenance purposes. Unless the tug was on shore power, the on-board diesel generator was always in service.

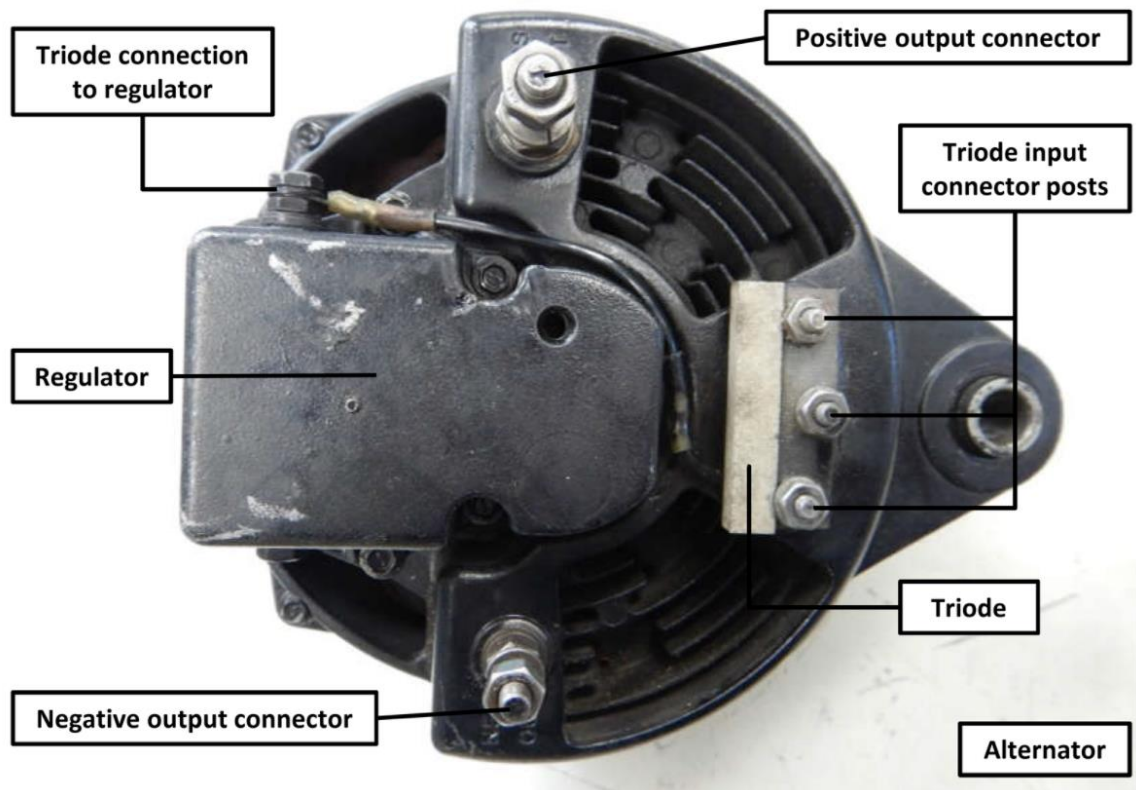
Figure 9. Alternator and its external components (Source: TSB)

The alternator had no marking other than a sticker indicating "32 volts" and some handwritten markings. The investigation could not identify the manufacturer, date, model, or serial number of the alternator. The components of the alternator (the regulator, triode, and connectors) are shown in Figure 9.
