MARINE TRANSPORTATION SAFETY INVESTIGATION REPORT M21P0030

SINKING AND LOSS OF LIFE

Tug *Ingenika* and barge *Miller 204*
Gardner Canal, British Columbia
10 February 2021

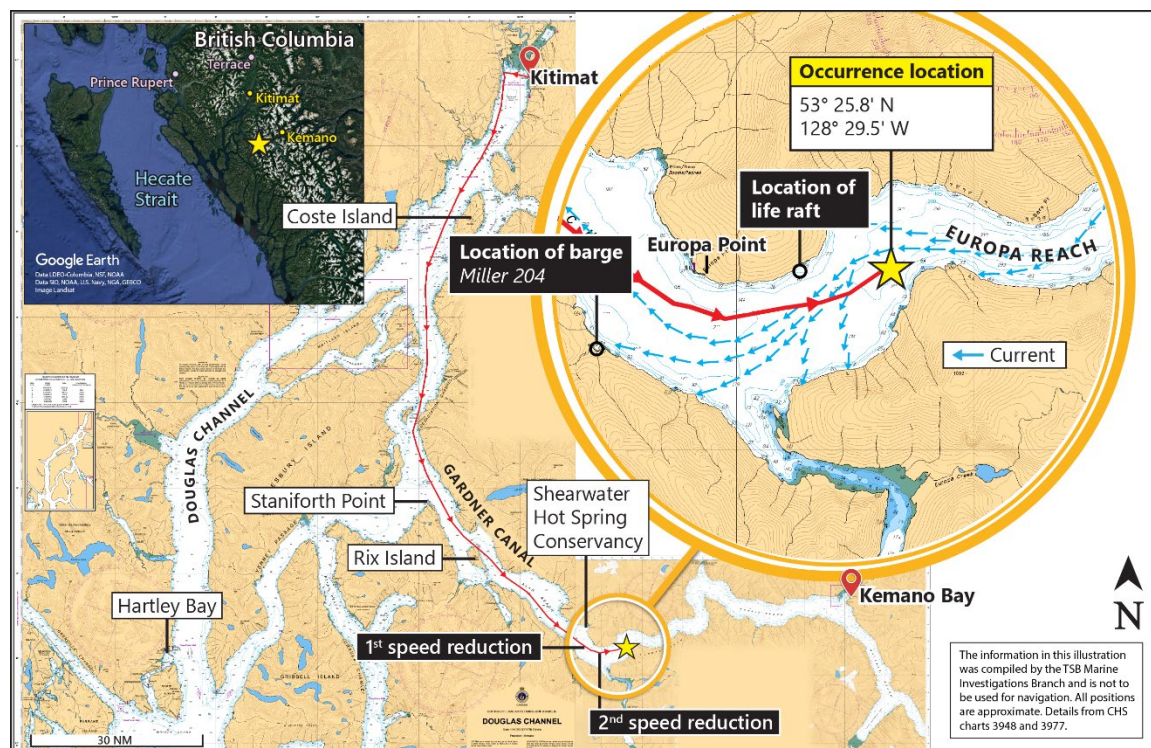
Figure 4. Chart, inset chart, and inset map showing the location of the occurrence (Source of chart and inset chart: Canadian Hydrographic Service, with TSB annotations. Source of inset map: Google Earth, with TSB annotations)

As the tug proceeded past Rix Island, its speed began to fluctuate and decrease. At 2152, as the tug and barge were rounding Europa Point, the tug's speed dropped to below 1 knot (Figure 4, 1st drop in speed). The tug regained some speed, but at 2213, it dropped below 1 knot again (Figure 4, 2nd drop in speed). The tug then proceeded on an east-northeasterly course with the speed continuing to fluctuate between 0.6 and 3.1 knots.

DH1 retrieved 3 immersion suits from a locker in the accommodation and passed them up to DH2 one at a time due to their bulkiness. DH1, attired in pyjama pants and a long-sleeve shirt, left the accommodation and climbed up the ladder to the wheelhouse. The ladder was at an angle because of the vessel's starboard heel. As DH1 was climbing up the ladder, the master was making a Mayday call using the VHF radiotelephone and donning an immersion suit. DH2 was also donning an immersion suit. The tug's engines were no longer running.¹² The last AIS transmission from the tug was logged at 2311:27. At this time, the *Ingenika* was in Europa Reach at position 53°25.89' N, 128°29.4' W, approximately 16 nautical miles (NM) from Kemano (Figure 4).
