Marine Occurrence Report

Grounding

"FEDERAL MACKENZIE"
Verchères-Contrecoeur Channel, Quebec
14 July 1993

Report Number M93L0002

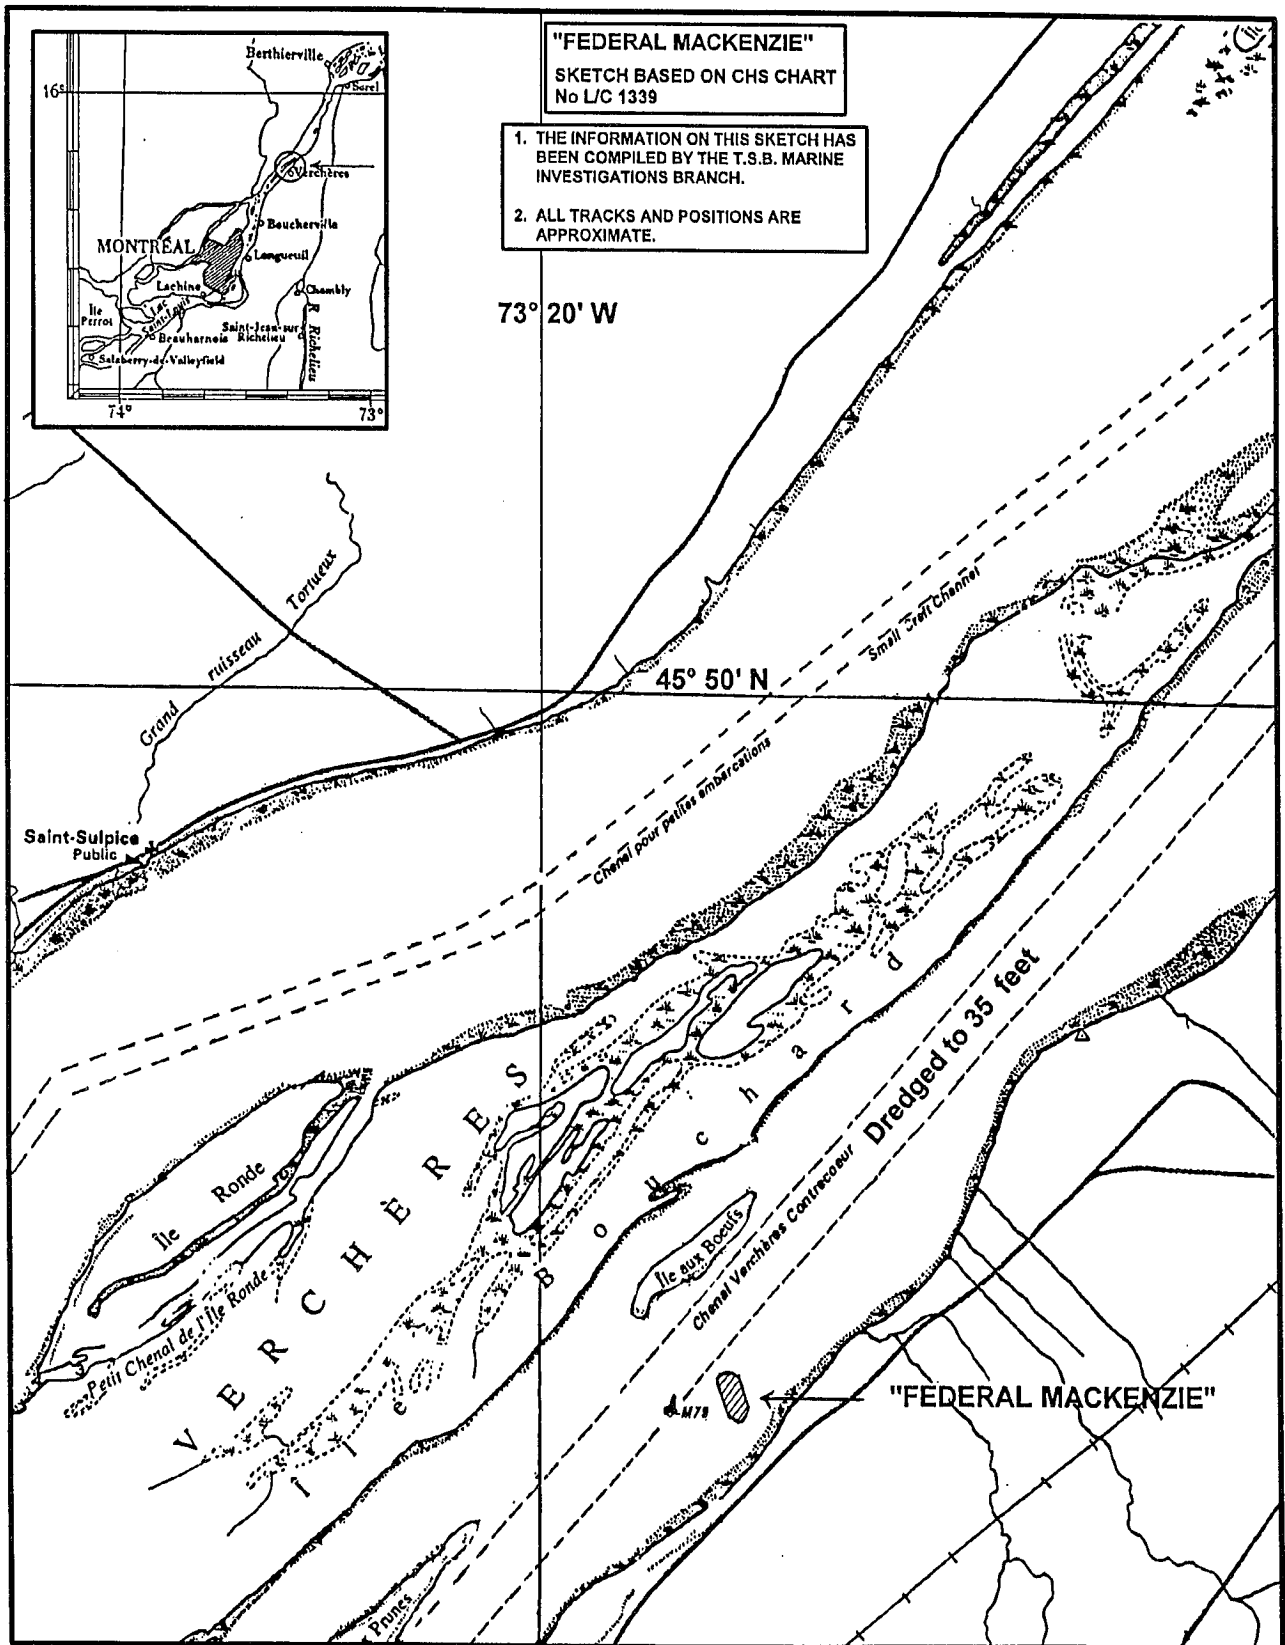
Appendix B - Sketch of the Area of the Grounding

While upbound in the St. Lawrence River, the laden bulk carrier "FEDERAL MACKENZIE" grounded on the south side of the Verchères-Contrecoeur Channel, Quebec. There was no apparent damage to the vessel and there were no injuries.

indicates that there was considerable vibration attributed at the time to shallow water beneath the keel. During the transit of the channel, the main engine failed. The engine-room employees were unable to restart the engines in time to avoid the grounding.
