PIPELINE TRANSPORTATION SAFETY INVESTIGATION REPORT P21H0143

THIRD-PARTY DAMAGE TO A NATURAL GAS PIPELINE

Minell 6-inch natural gas pipeline

Near McAuley, Manitoba

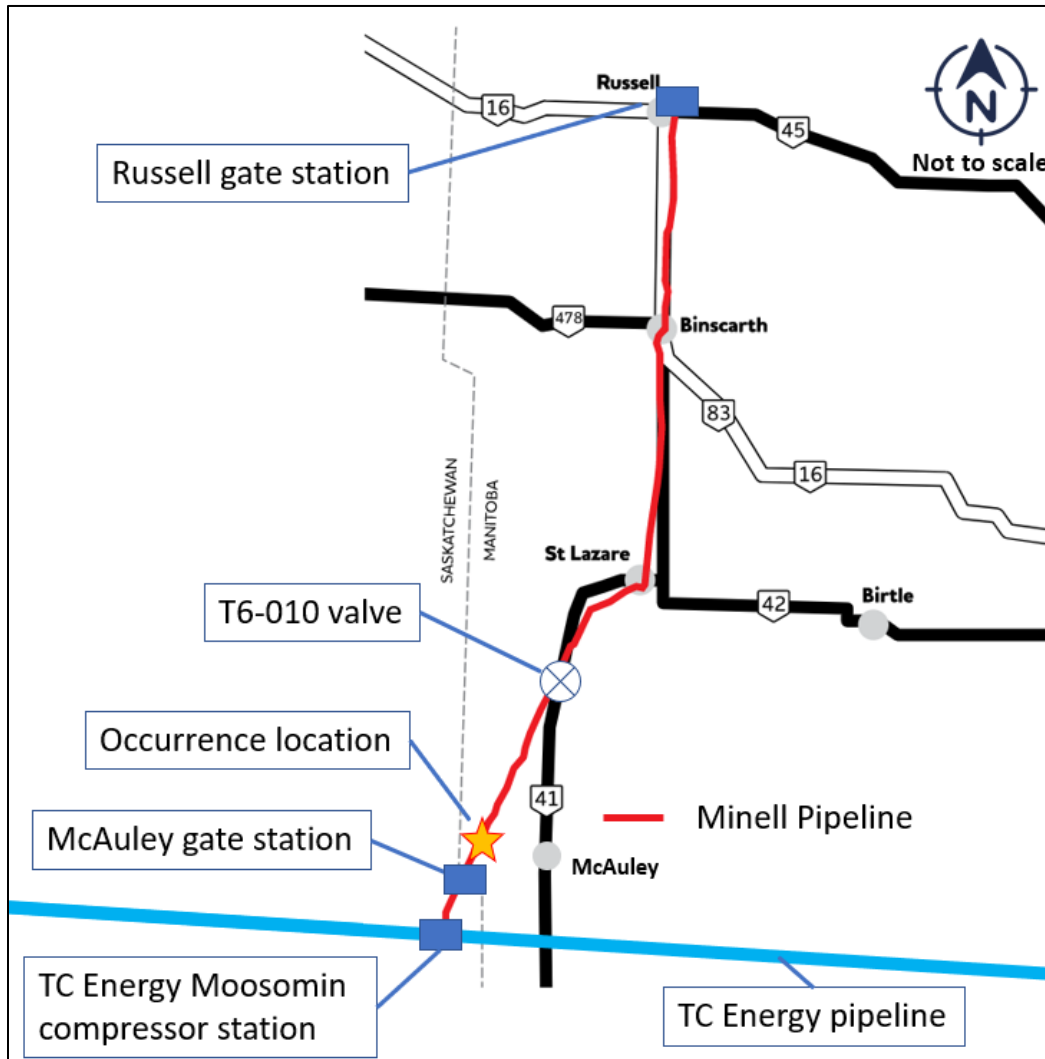
Figure 6. Minell Pipeline (Source: Manitoba Hydro, with TSB annotations)

The Minell Pipeline, owned and operated by Manitoba Hydro, is part of the provincial gas transmission network in Manitoba. It originates near Moosomin, Saskatchewan, and extends for about 70 km to where it terminates in Russell at a gate station. The pipeline passes through or near the towns of McAuley (population of 270), St. Lazare (population of 257), Binscarth (population of 420), and Russell (population of 1395) (Figure 6).

The McAuley gate station is on the south side of Highway 703, near the Saskatchewan-Manitoba border (see Figure 6). It is the first gate station downstream of TC Energy's Moosomin compressor station and is the first set of control valves on the Minell Pipeline accessible by Manitoba Hydro; there are approximately 4 km of pipeline between the 2 stations.

Gas flow into the 4 km section of the Minell Pipeline connecting TC Energy's Moosomin compressor station and the McAuley gate station (see Figure 6) can only be turned off by TC Energy. This is achieved by the manual shutdown of a valve located within TC Energy's Moosomin compressor station. During business hours, when TC Energy staff are on site, the valve can be closed within 5 minutes; after hours, calls can be responded to by TC Energy staff within 2 hours. Manitoba Hydro does not have access to the Moosomin compressor station and does not have a formal agreement with TC Energy to isolate the Minell Pipeline or to cooperate in emergency response activities.

The McAuley gate station is the first point where Manitoba Hydro has access to control flow on the Minell Pipeline. Gas supply into the 4 km segment between the pipeline supply at TC Energy's Moosomin compressor station and the McAuley gate station (see Figure 6) can only be shut down by TC Energy. Manitoba Hydro does not have an isolation plan for the segment of pipe upstream of the McAuley gate station.

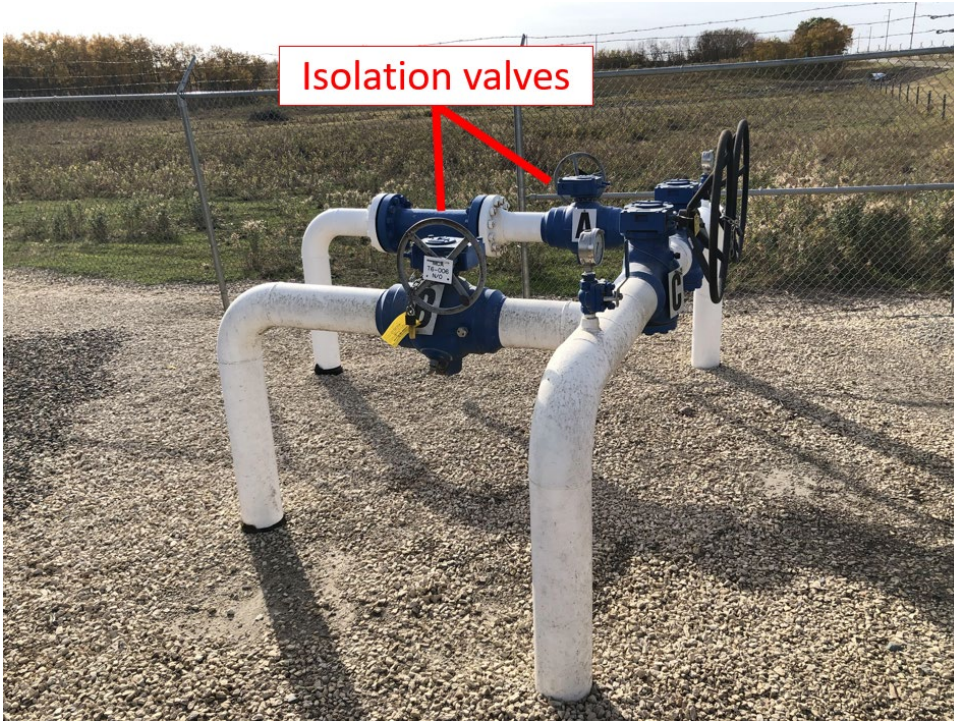
Figure 7. McAuley gate station bypass and isolation valves (Source: Canada Energy Regulator, with TSB annotations)

The gate station is fenced; within the yard area, there is a set of above-ground valves used to bypass or isolate the station (Figure 7). The valves are nominal 6-inch ball valves and are operated manually. The McAuley gate station is not staffed, and the nearest Manitoba Hydro staff are based in either Russell or Virden, each approximately 70 km away by road.

The Minell Pipeline is a single-feed pipeline, and is shut down by manually closing the 2 isolation valves (see Figure 7) at the McAuley gate station. No valves can be actuated remotely or automatically to isolate or shut down any part of the Minell Pipeline in the event of an emergency.
