RAILWAY INVESTIGATION REPORT

R00M0044

MAIN-TRACK DERAILMENT

BLUE BELL, NEW BRUNSWICK

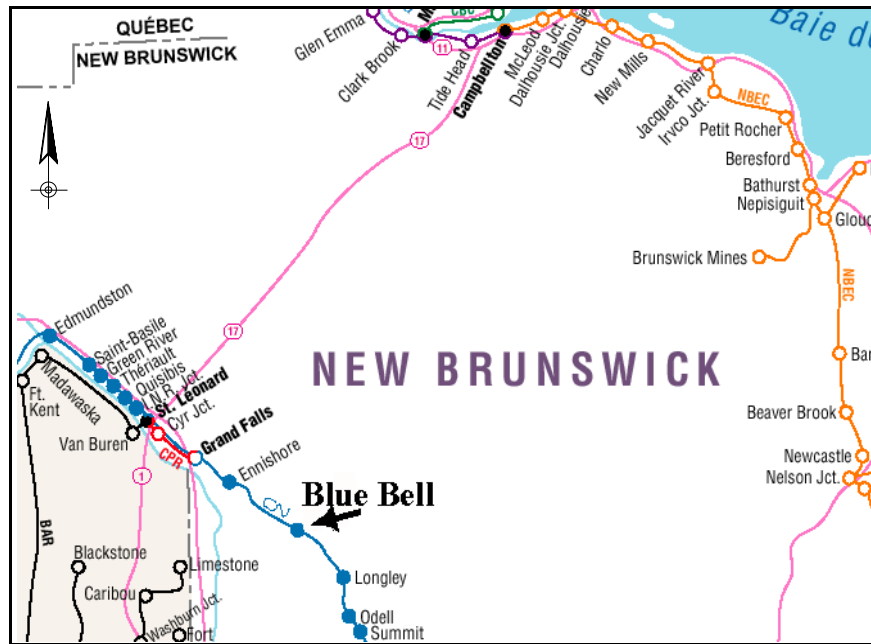
The train was travelling eastward from Montréal, Quebec, destined for Halifax, Nova Scotia. As the train approached Mile 163.1 of the Napadogan Subdivision, a train-initiated emergency brake application occurred. After conducting the necessary emergency procedures, the crew determined that seven multi-platform, double-stack container cars, located 24th to 30th in the consist, had derailed. In all, 24 platforms carrying 36 containers were involved. Several container flats were upside down in the ditches on both sides of the right-of-way. Three containers were subsequently recovered and sent on to their destination.
