RAILWAY INVESTIGATION REPORT

R03T0047

YARD COLLISION

CANADIAN NATIONAL
TANK CAR PROX 77811
MILE 25.0, YORK SUBDIVISION
TORONTO, ONTARIO
22 JANUARY 2003

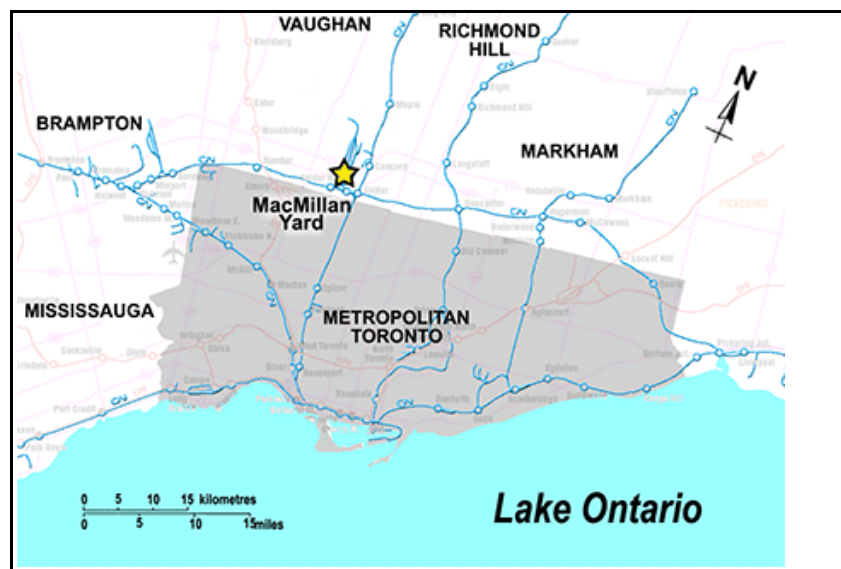
On 18 January 2003, car PROX 77811, a class 111A60W-1 tank car built in 1969, was interchanged from the Ontario Northland Railway to Canadian National (CN) in Cochrane, Ontario. The tank car arrived in Toronto, Ontario, at MacMillan Yard (see Figure 1) on 19 January 2003. During the inbound certified car inspection (CCI), a wheel tread defect was identified and the tank car was placed in bad order status. On its way to the repair track, the tank car was sent over the dual hump (see Figure 2). While passing over the revenue scale, it was determined that the tank car contained 1240 pounds (or approximately 630 litres) of fuel oil (UN 1202). Since this tank car was being used to transport a regulated product, the car was placarded. The movement of placarded rail cars must be performed in compliance with the *Transportation of Dangerous Goods Regulations*.

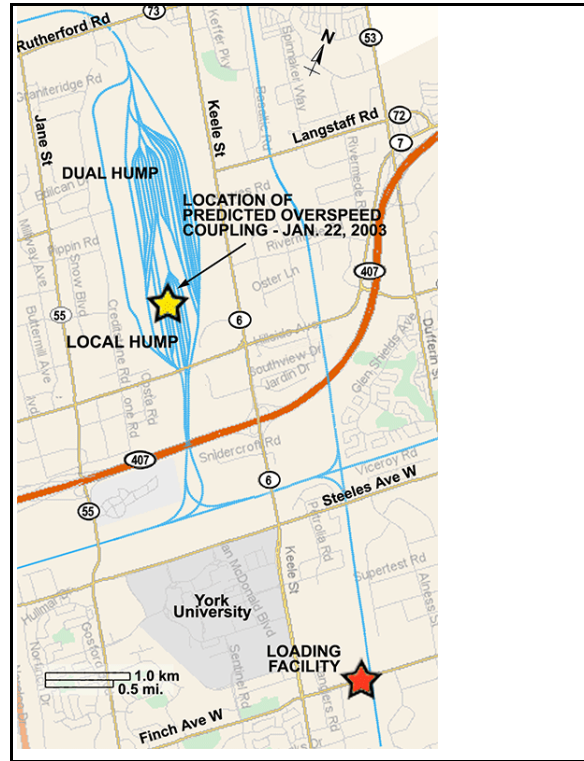
south (see Figure 2). After pumping approximately 3200 litres of diesel fuel into the tank car, the product was observed to be leaking from the sill area on the A-end of the car. Loading was stopped and the product was contained within a ground recovery system at the facility. The remaining product was pumped from the tank car. The car owner, Procor LP, was notified of the defect. After marking the tank car to identify the defect, the shipper released the tank car back to CN, destined for Procor's repair facility in Sarnia, Ontario.
