RAILWAY INVESTIGATION REPORT
R04T0008

MAIN-TRACK DERAILMENT

CANADIAN PACIFIC RAILWAY
TRAIN NO. 239-13
MILE 178.20, BELLEVILLE SUBDIVISION
WHITBY, ONTARIO
14 JANUARY 2004

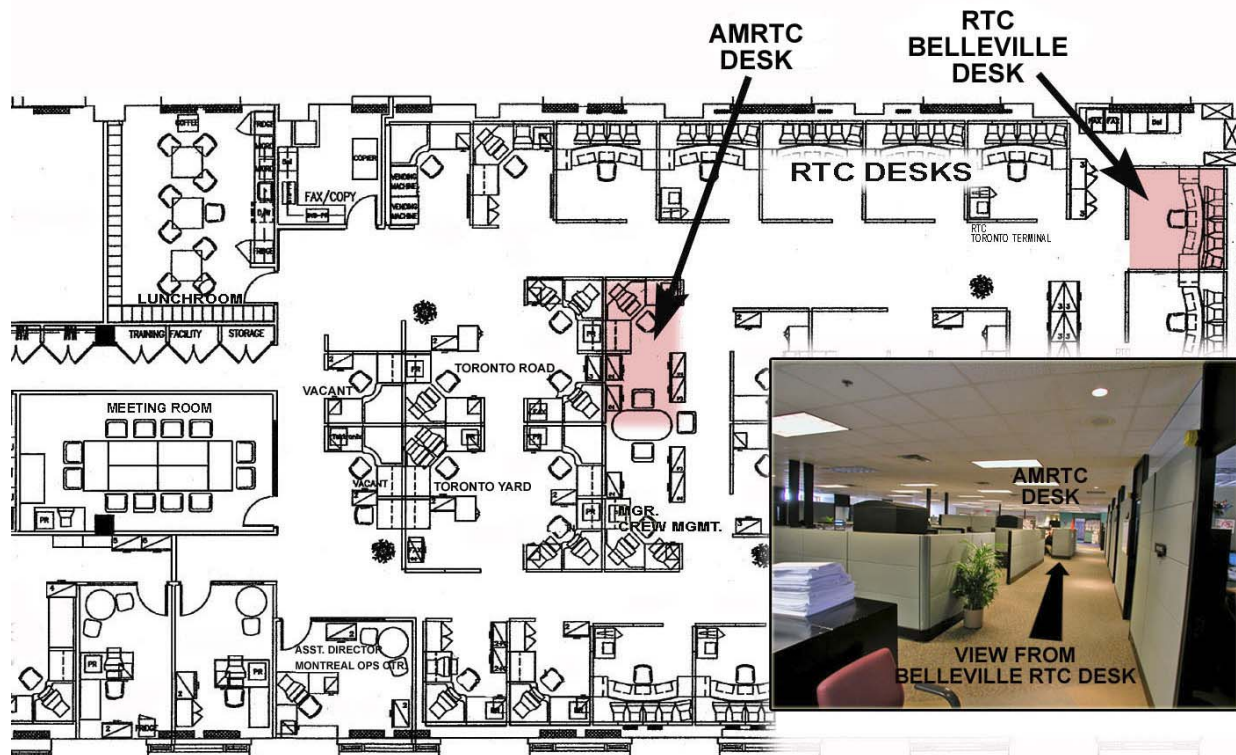
Figure 3. Montréal control centre floor plan. Inset photo shows view of AMRTC desk from door of Belleville RTC desk.

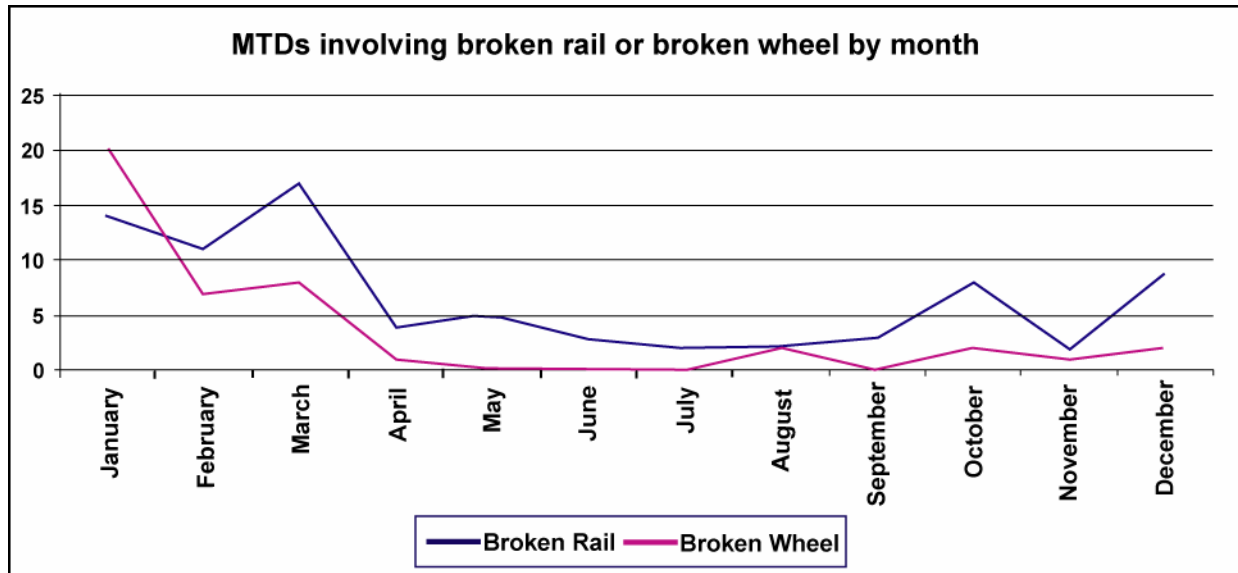
Figure 4. MTDs involving broken rail or broken wheel by month – 1999-2004 (Source: TSB occurrence database)

For MTDs involving broken rail, 64 per cent (that is, 51 of 80 derailments) occurred between December and March. The average temperature for these occurrences was -14.5°C , with the temperature ranging from -35.5°C to 6.0°C . For MTDs involving broken wheels, 86 per cent (that is, 37 of 43 derailments) occurred between December and March. The average temperature for these occurrences was -13.7°C , with the temperature ranging from -37.6°C to 8.6°C .

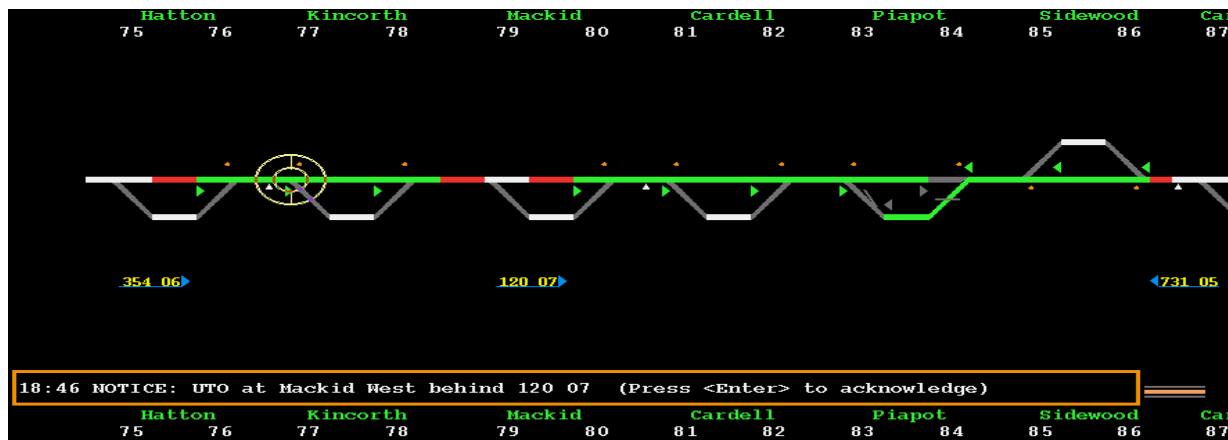
When a track occupancy occurs behind a tagged train, the following alert will appear on the RTCs workstation:

When this alert appears on the RTC workstation, the keyboard will lock up preventing any further keystrokes until the ENTER button is pressed.
