RAILWAY INVESTIGATION REPORT
R04V0173

MAIN-TRACK TRAIN DERAILMENT

CANADIAN PACIFIC

MILE 41.30, CANADIAN NATIONAL YALE SUBDIVISION

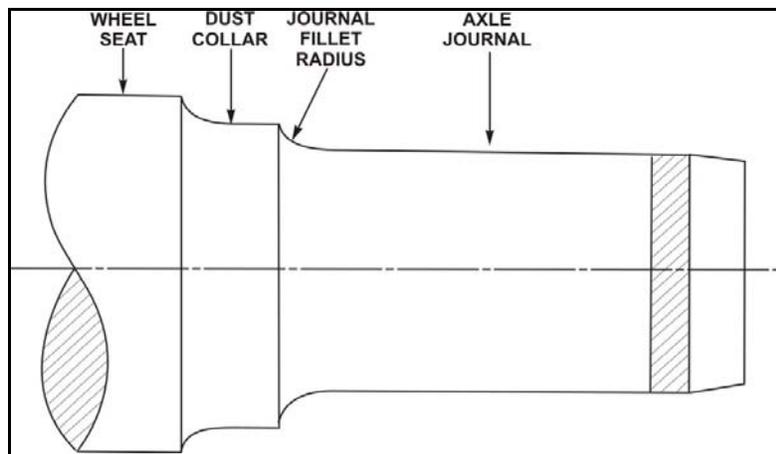
Figure 2. Freight car axle journal

Roller bearings are press-fit onto the journals. Railway wheels are press-fit onto the wheel seats. The journal and wheel seat have different cross-sectional diameters. There are two consecutive radii which transition from the larger diameter wheel seat to the smaller journal. The dust collar extends from the wheel seat to the top of the journal fillet radius; in turn, the journal fillet radius extends from the bottom of the dust collar to the journal surface. Both are supposed to be smooth contoured transitions (see Figure 2).
