## **RAILWAY INVESTIGATION REPORT**

**R05Q0033**

### **MAIN-TRACK DERAILMENT**

**CANADIAN NATIONAL**

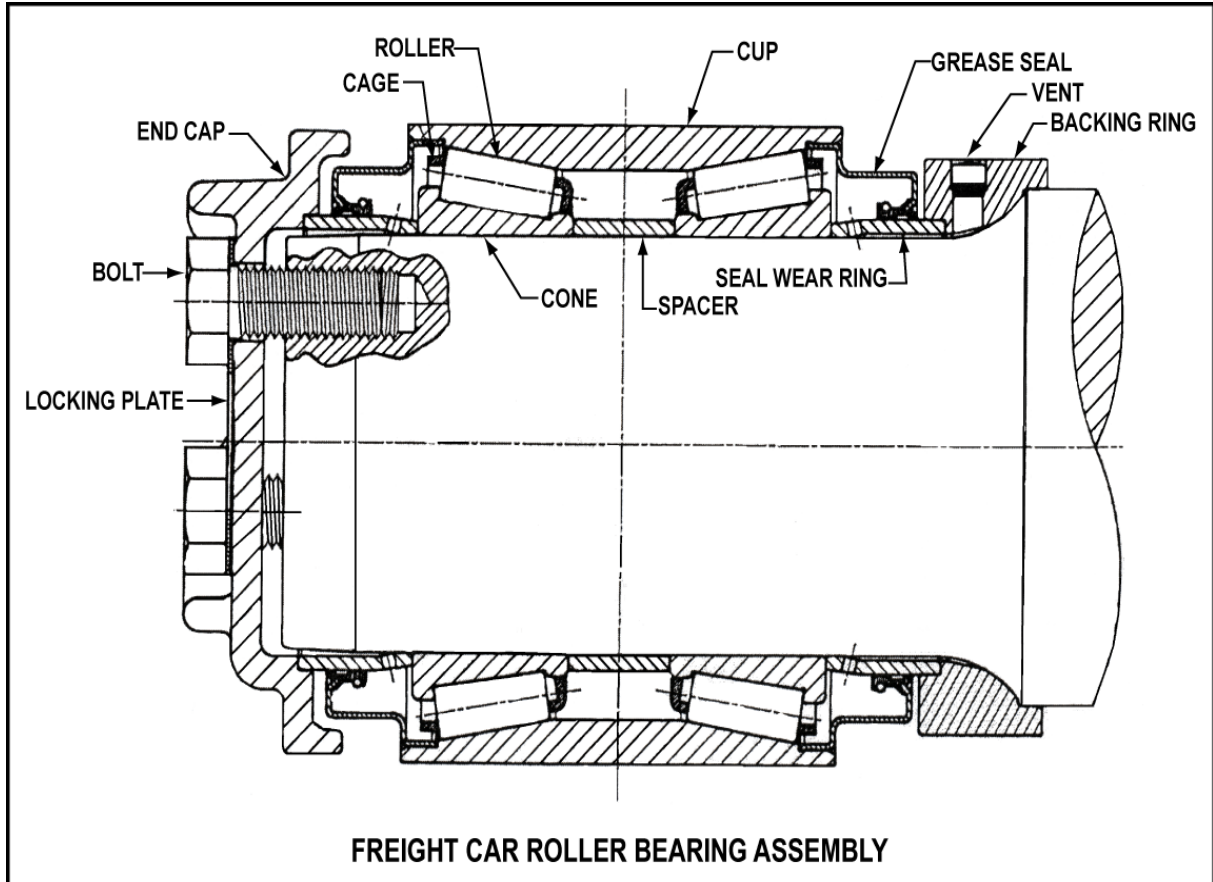
*Appendix A – Schematic of Typical Freight Car Roller Bearing Assembly*

Roller bearings consist of an outer race, two tapered roller bearings with inner races separated by a spacer, and two (inner and outer) grease seals with wear rings. This assembly is pressed on an axle against a backing ring and then retained by the end cap, which attaches to the end of the axle via three cap screws and a locking plate (see Photo 2 and Appendix A).

The bearings on wheel R-2 were Class E Brenco 6 X 11, AAR-5A. When they were assembled, they were equipped with rubber cap screw seal rings between the end cap and the axle. In May 1988, the AAR prohibited the further use of these cap screw seal rings as they were susceptible to reducing the clamping forces on the assembly, which can contribute to premature failure of the bearing. Examination of the end cap and related components from the R-2 position revealed only residues of these seal rings.
