**RAILWAY INVESTIGATION REPORT
R08M0015**

MAIN-TRACK DERAILMENT

VIA RAIL CANADA INC.

MILE 23.32, MONT-JOLI SUBDIVISION

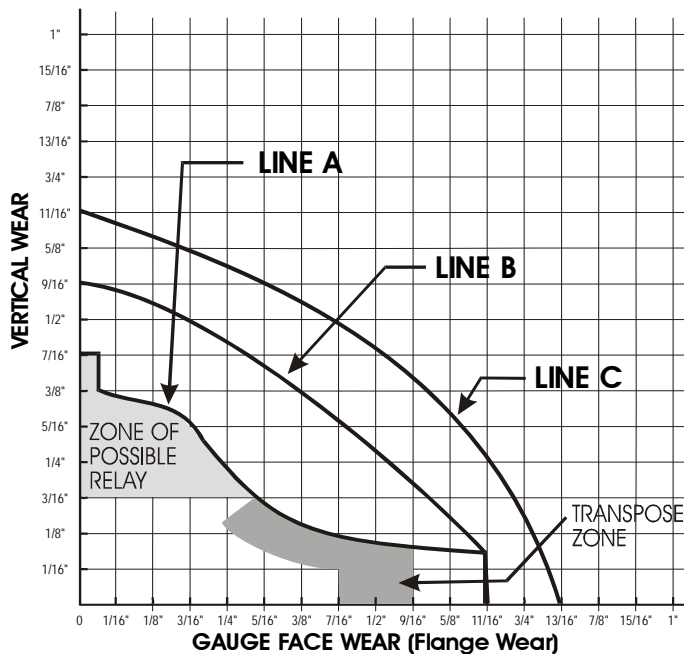
RAIL WEAR LIMITS & RAIL MANAGEMENT DECISION ZONES

According to observations by CFMG track maintenance employees, the frequency of VSH defects increases when rail head wear exceeds 11 to 12 mm. A 3D finite element analysis (FEA) was undertaken to evaluate how vertical head wear influences the stresses on the head. FEA models were defined according to four different degrees of vertical head wear: 0 mm, 8 mm, 12 mm, and 16 mm. Stress distribution in a rail head is very complex, and the model considered for FEA requirements used simplified wheel load support points and bearing points. The stresses and loads in this model therefore do not exactly represent those that are applied to a rail in service. Nevertheless, this model is considered suitable for carrying out a comparative analysis and provides qualitative information on how vertical wear influences the stresses on the rail head.

Rail Section 115 lb. RE
