**RAILWAY INVESTIGATION REPORT
R11T0034**

**DAMAGE TO ROLLING STOCK WITHOUT
DERAILMENT OR COLLISION
VIA RAIL INCORPORATED
PASSENGER TRAIN 70
MILE 21.40, OAKVILLE SUBDIVISION
OAKVILLE, ONTARIO
06 FEBRUARY 2011**

Report Number R11T0034

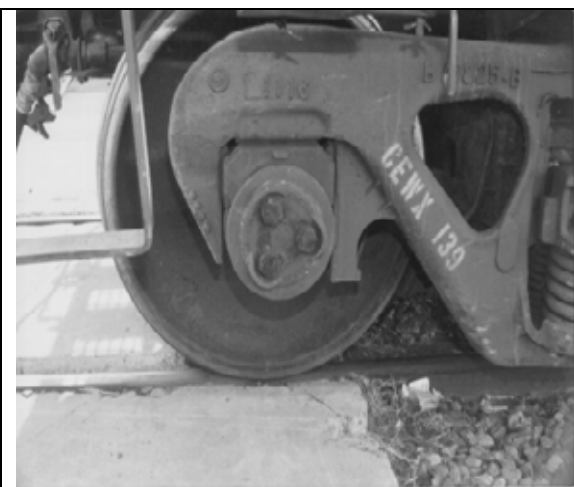
Photo 1. Freight car arrangement

VIA has about 220 HEP coaches, which represents approximately 50% of its fleet. About 20% of the HEP coaches operate at speeds up to 95 mph and in the Quebec–Windsor corridor while the remaining HEP coaches operate on VIA’s transcontinental route. On average, HEP coaches travel about 138 000 miles per year. HEP coaches are equipped with 6 ½ inch X 12 inch outboard roller bearings and rely primarily on wayside HBDs for protection against enroute roller bearing failure. Unlike freight cars (Photo 1), roller bearings on the HEP cars are encased in a large journal box (Photo 2).
