**RAILWAY INVESTIGATION REPORT
R12E0008**

MAIN-TRACK DERAILMENT

**CANADIAN NATIONAL RAILWAY
FREIGHT TRAIN M30141-20
MILE 149.21, WAINWRIGHT SUBDIVISION
FABYAN, ALBERTA
21 JANUARY 2012**

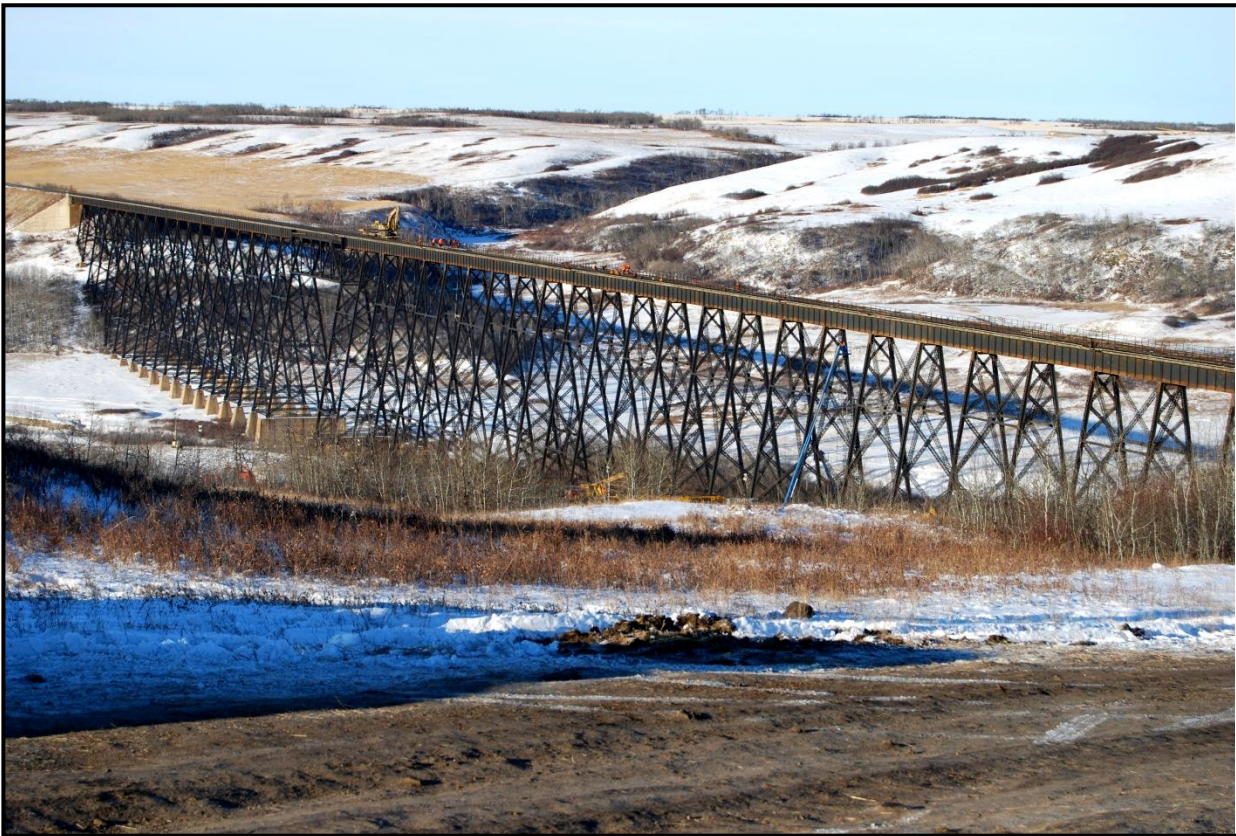
Fabyan Bridge is a 2869-foot-long viaduct that spans the Battle River Valley and is a key structure in CN's mainline route (Photo 5). It has a maximum height of 190 feet. The bridge consists of:

Photo 5. Fabyan Bridge (looking west)

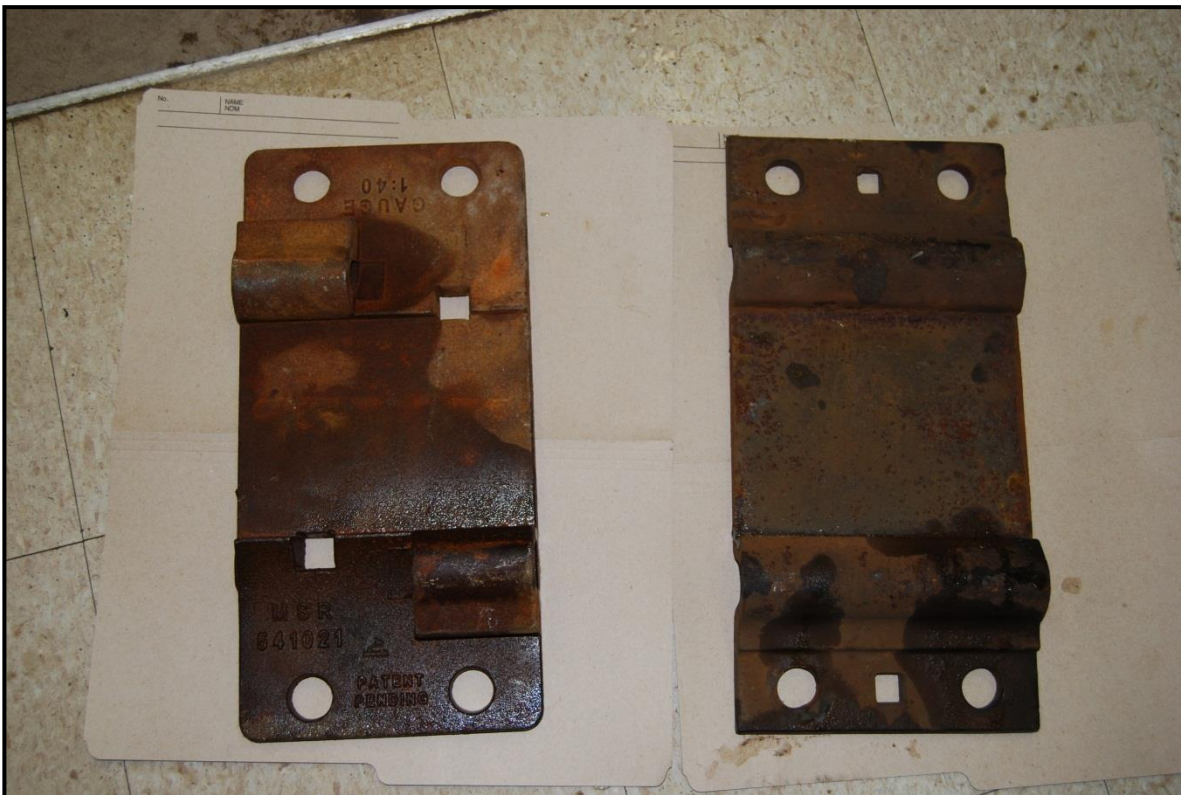
In contrast to the conventional fastening system, cast-plate and rolled-plate fastening systems (Photo 6) provide the 2 separate fastener functions. The rail is attached to the tie plate with an elastic fastener, normally an “e”-shaped round heat-treated steel bar (20 millimetres in diameter). The tie plate is then attached to the tie with lag screws or a combination of screws and spikes. The cast ductile iron tie plate has wedge-shaped lugs in the bottom that embed in the wood tie to add extra holding power. Rolled plates have smooth bottoms without lugs (Photo 7).

Photo 6. Cast plate (left) and rolled plate (right)

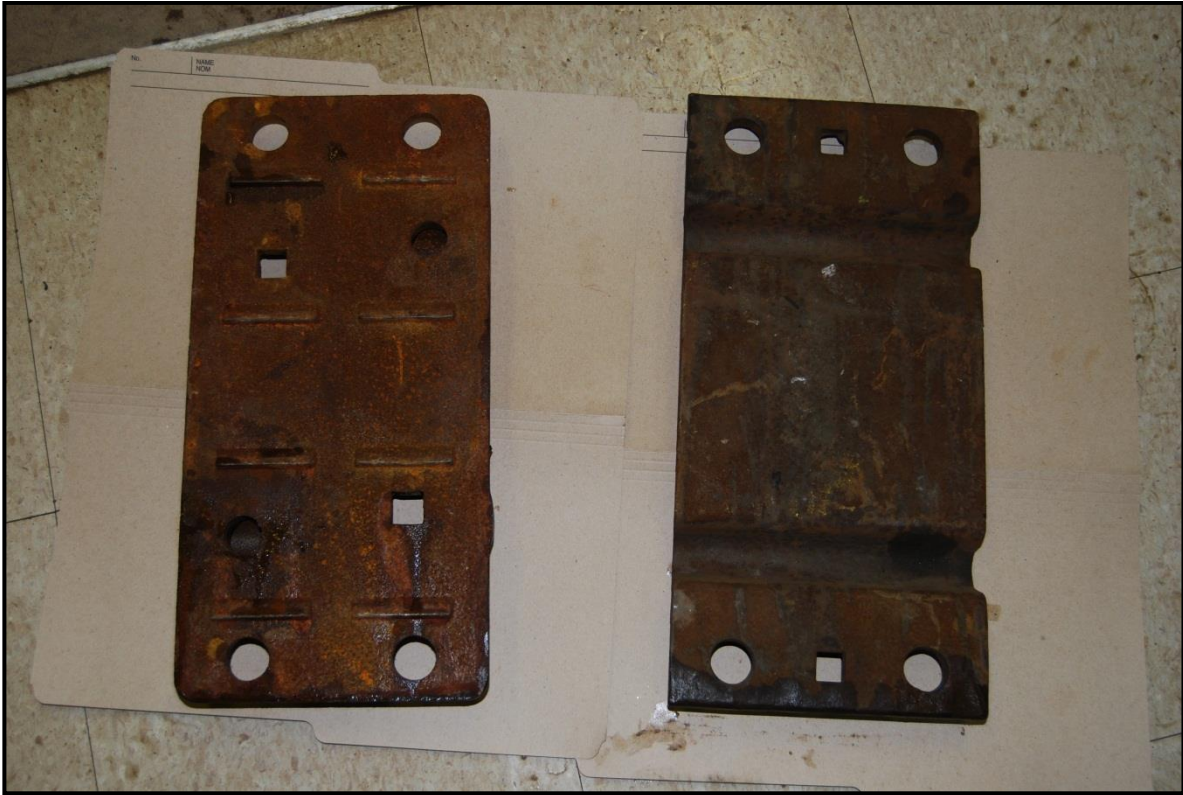
Photo 7. Bottom of plates (Note: lugs on bottom of cast plate [left] and smooth bottom of rolled plate [right])
