RAILWAY INVESTIGATION REPORT R13T0192

CROSSING COLLISION

**VIA RAIL CANADA INC. PASSENGER TRAIN NO. 51
OC TRANSPOR DOUBLE-DECKER BUS NO. 8017
MILE 3.30, SMITHS FALLS SUBDIVISION
OTTAWA, ONTARIO
18 SEPTEMBER 2013**

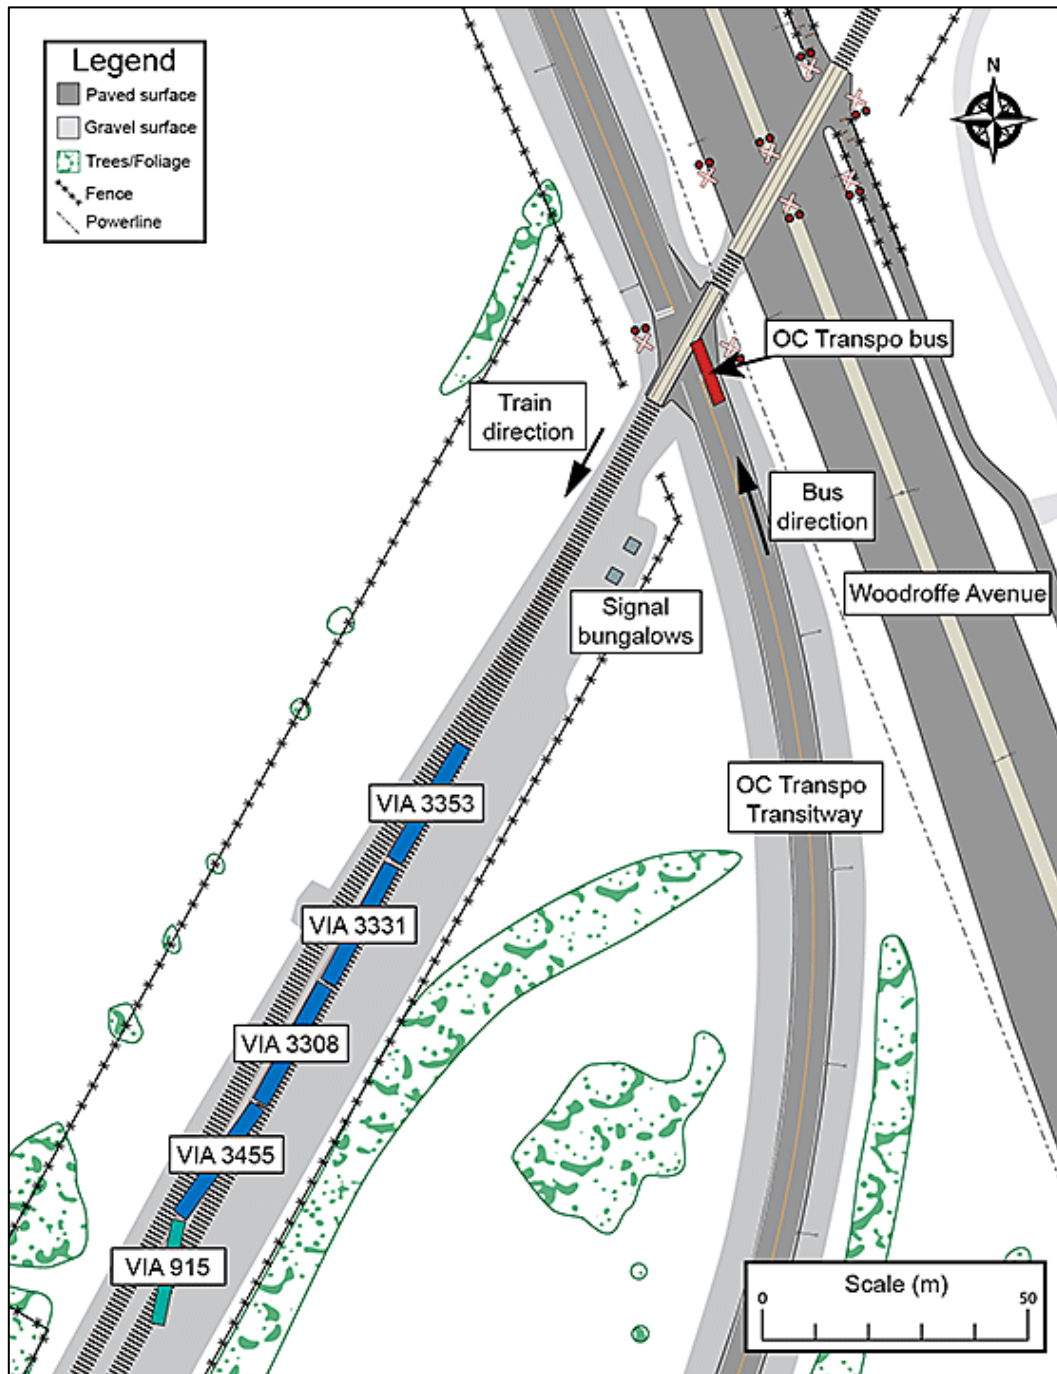
Figure 2. Site diagram

The train subsequently derailed and the locomotive came to a stop approximately 690 feet (210 m) west of the Transitway crossing, just east of the VIA Fallowfield Station (Figure 2).

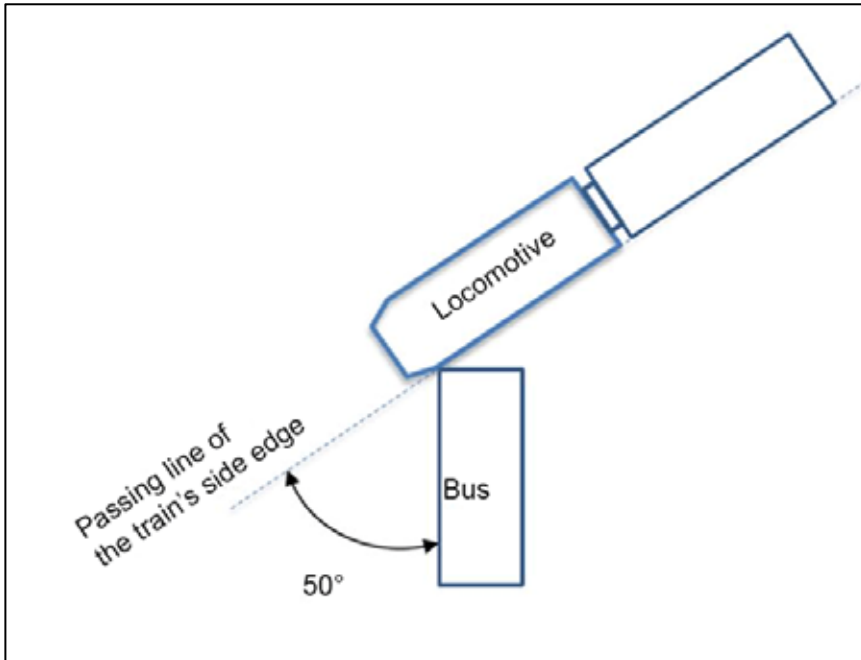
Figure 3. Orientation of the bus and train just prior to impact

At the railway crossing, the Transitway crosses the track at a 50-degree angle. The relative orientation of the bus and the locomotive just prior to impact is depicted in Figure 3.

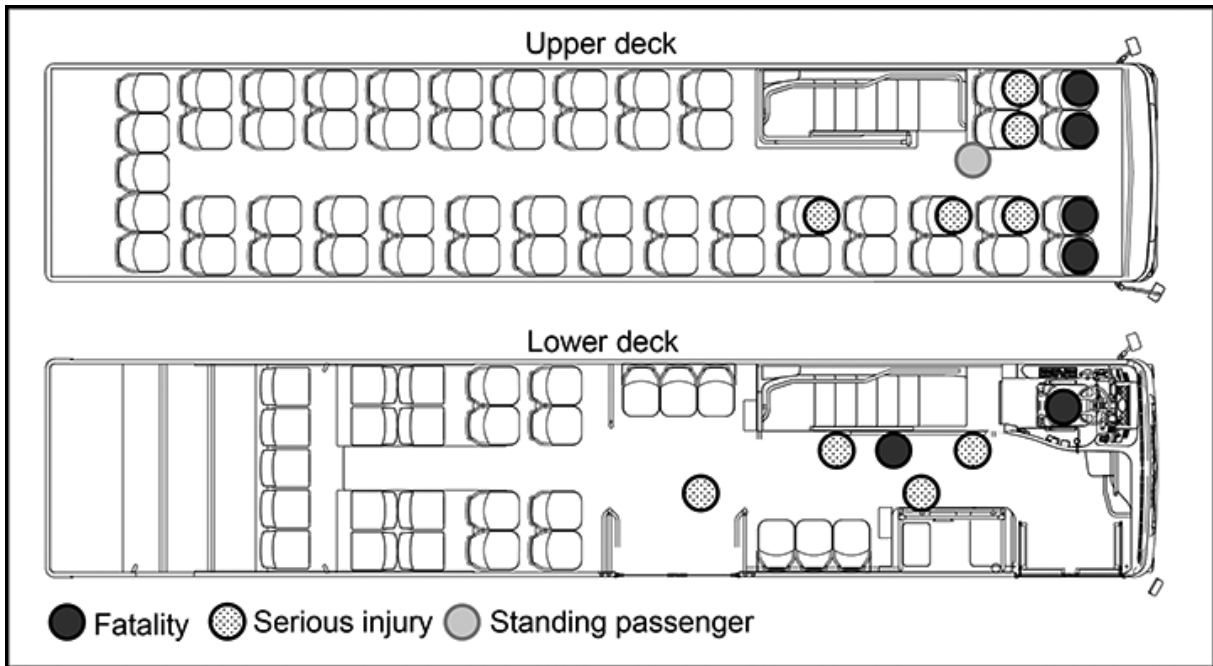
Figure 5. Double-decker bus layout with location of occupants who sustained fatal and serious injuries

On the VIA train, there were no injuries to crew members or passengers. Among the bus occupants, there were 6 fatalities, 9 serious injuries⁹ and about 25 minor injuries. The location of the bus occupants who sustained fatal and serious injuries is depicted in Figure 5.

The driver and the 4 passengers seated in the first row of the upper deck were ejected from the bus and sustained fatal injuries. An additional passenger on the lower deck was thrown to the front of the bus and later succumbed to fatal injuries.

Four passengers seated in rows 2 and 3 of the upper deck were also ejected from the bus. These 4 passengers and a 5th passenger in the 5th row of the upper deck as well as 4 passengers on the lower deck sustained serious injuries.

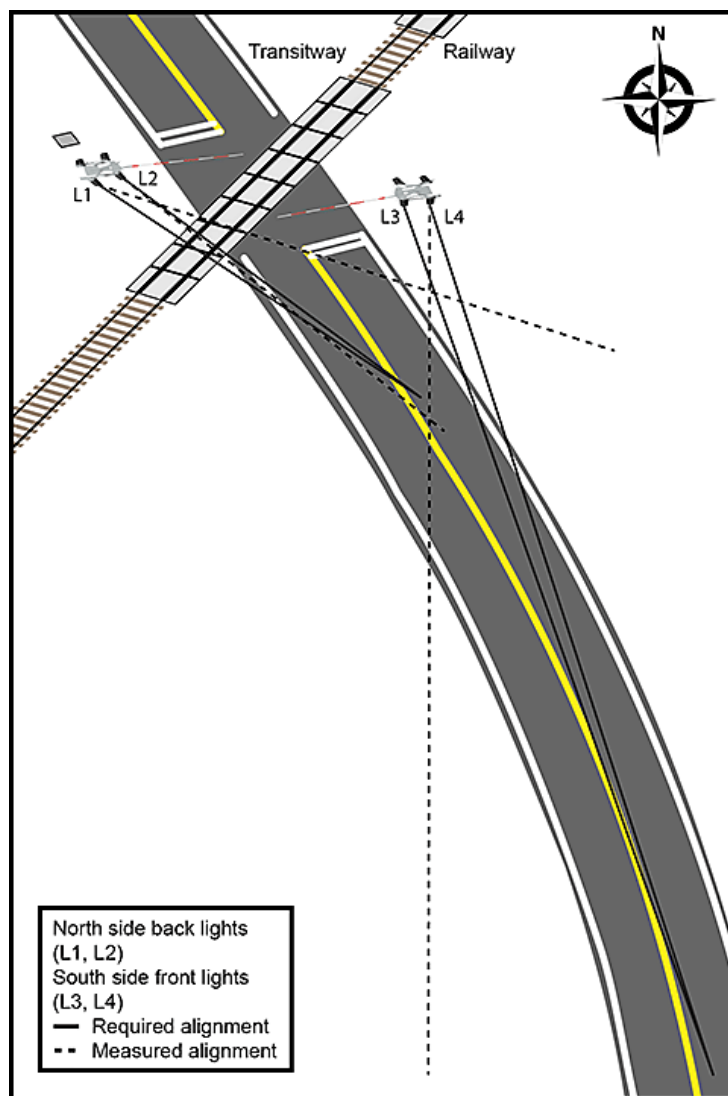
Figure 8. Transitway crossing light layout and alignment

11. Although the crossing LED lights were clearly visible to roadway vehicles on the Transitway, the LED lights facing southward for the Transitway were misaligned. For a road speed of 60 km/h (i.e., Transitway speed limit at the time of the accident), the short lights (back lights located on the north stanchion – L1 and L2 in Figure 8) should have been aimed at a location 50 feet (15.2 m) south of the northbound lane stop line at the crossing, at the driver position, 5.2 feet (1.6 m) above the road surface. The long lights (front lights located on the south stanchion – L3 and L4 in Figure 8) should have been aimed at a location about 280 feet (85.3 m) south of the northbound lane stop line.

- For the south-side front lights (long), the west light (L3) was aligned properly at 280 feet (85.3 m) while the east light (L4) was aimed about 50 feet (15.2 m) to the west, 280 feet (85.3 m) from the south stop line (Figure 8).

12. The larger road sign also obscured the driver’s view of the south-side front lights (long) earlier on in the approach.

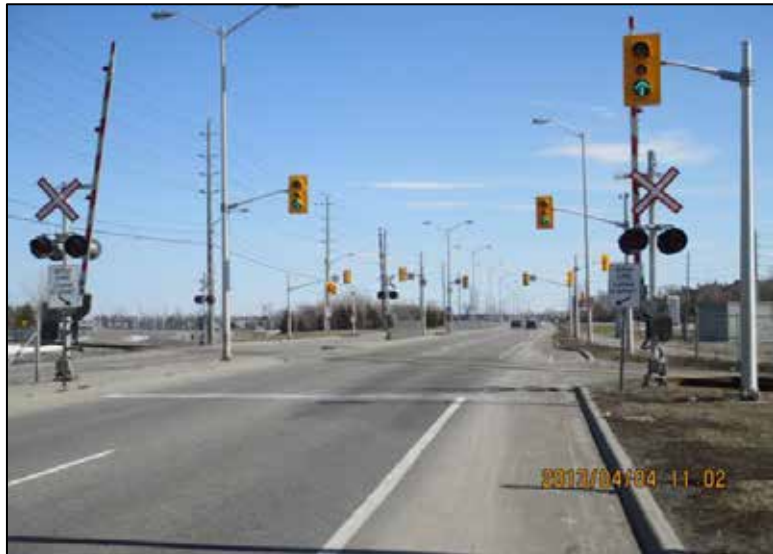
The crossing (Photo 15) AWD protection is interconnected with the traffic lights at the crossing and with the signalized intersection of Fallowfield Road and the Transitway. The interconnection is equipped with a pre-emption circuit. Once the railway AWD sequence is initiated, the roadway traffic lights at the Transitway turn green to allow traffic in the vicinity of the crossing to clear the crossing. The traffic lights

Photo 15. Fallowfield Road looking east (Source: Jock Valley Engineering)

then turn amber for several seconds followed by red displayed for a minimum of 13 seconds after which the crossing AWDs activate and the lights begin to flash for about 12 seconds before the gates begin to descend. All vehicles should be stopped in advance of the crossing stop line on the road and clear of the crossing when the lights on the crossing warning system start to flash. The Fallowfield Road/Transitway traffic lights cannot be seen from the roadway stop line for the crossing, but are visible to drivers if their vehicle is beyond the stop line.

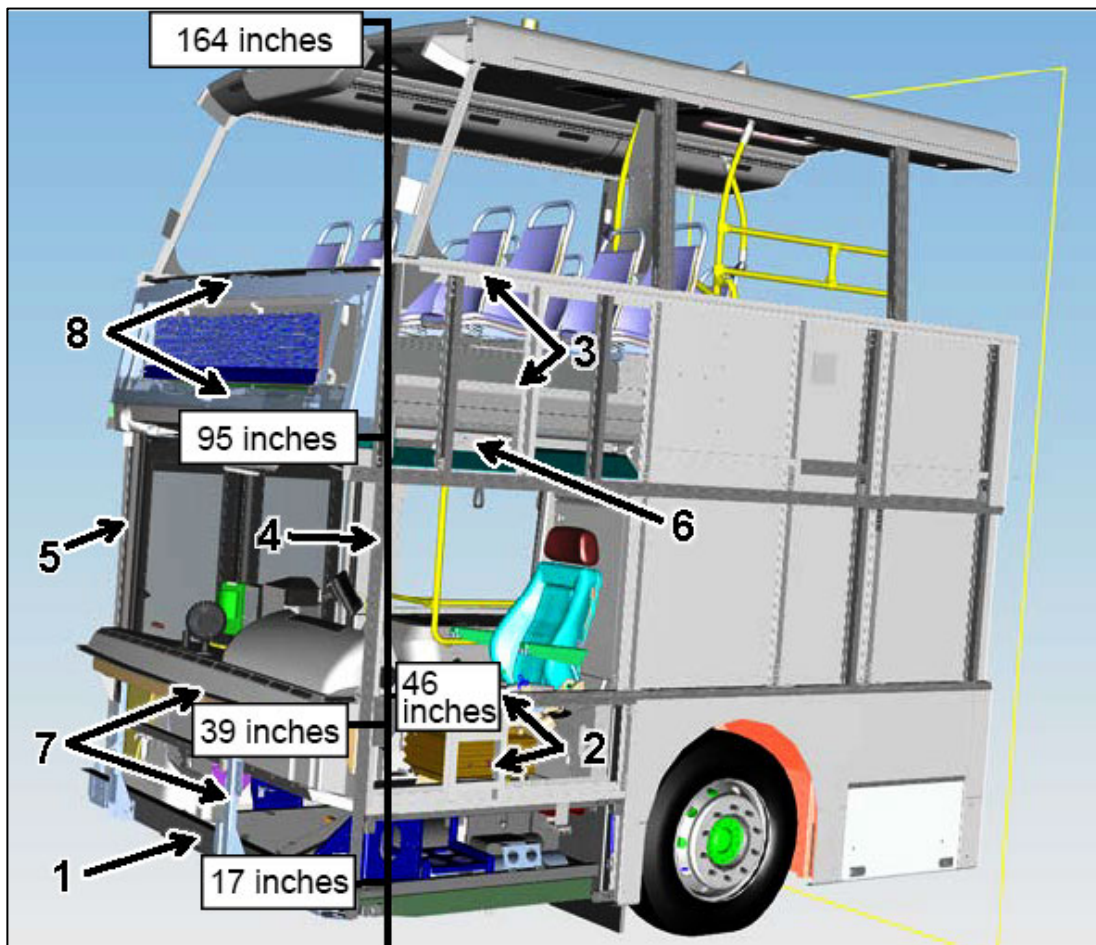
Figure 12. Schematic showing the front structure of the ADL E500 bus (Source: Alexander Dennis Limited, with TSB annotations)

The structural components of the front part of the bus are illustrated in Figure 12. (Note: The vertical scale in the figure indicates the height relative to ground level.)

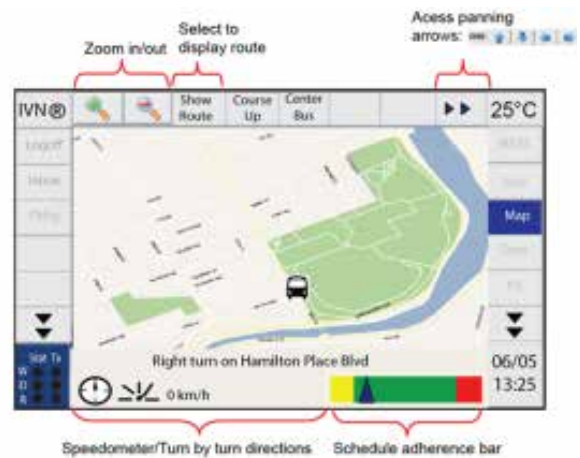
The input functions of the TCH were locked out to the driver when the bus was travelling at speeds in excess of 16 km/h (10 mph). At this speed, a map display was automatically displayed. However, input controls related to the map features, such as zoom, route shown, route options, panning, speedometer, turn-by-turn directions, and the schedule adherence bar, remained active at speeds above 16 km/h (Photo 20).

Photo 20. Transit control head display

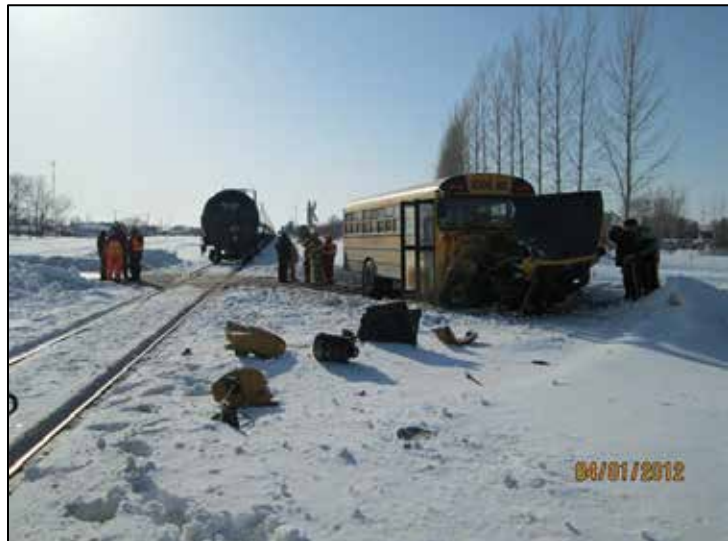
At about 1515 Central Standard Time on 26 March 2013, Canadian National (CN) freight train L50041-26 was proceeding eastward at 25 mph (40.2 km/h) on the Lampman Subdivision in Carlyle, Saskatchewan, when it struck a southbound school bus (the bus) transporting 7 elementary school children at the 4th Street East crossing (Photo J1). One passenger suffered minor injuries. The train weighed approximately 3000 tons and was about 1800 feet long.

Photo J1. Accident scene looking west (Source: Canadian National)

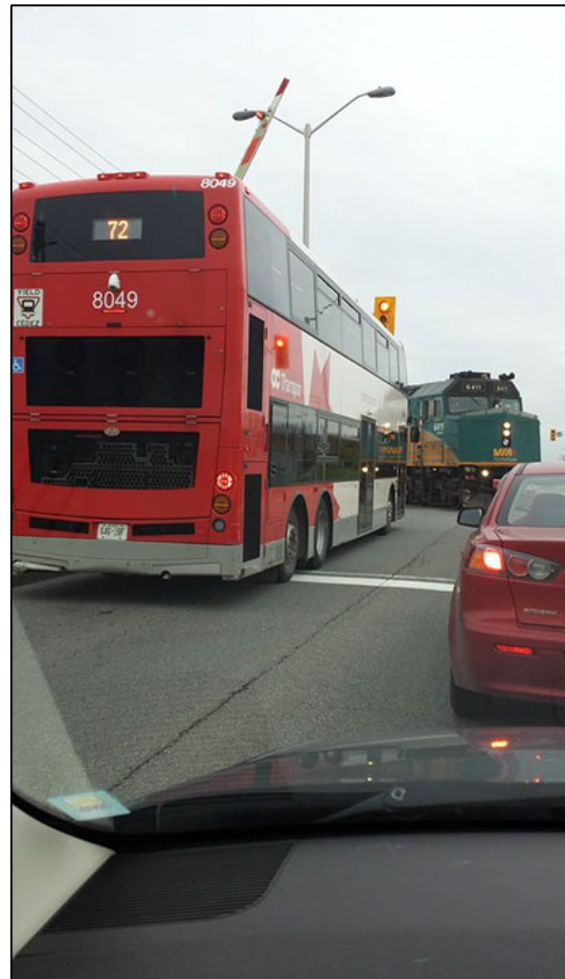
At 0749:02, the traffic signal turned to amber and then to red at 0749:07. During this sequence, OC Transpo bus 8049 came to a stop for the traffic light at a location that was about 25 feet (7.62 m) beyond the crossing roadway stop line. At 0749:33, the crossing AWD protection activated for a westbound VIA passenger train (southward at this location). Shortly thereafter (0749:41), a crossing gate lowered onto the roof of the bus (Photo K1). At 0750:14, the train arrived at the crossing. At 0750:44, the train cleared the crossing after which traffic resumed on Fallowfield Road.

Photo K1. Bus stopped past roadway stop line
(Source: social media)
