**RAILWAY INVESTIGATION REPORT
R14V0215**

**MAIN-TRACK DERAILMENT
CANADIAN NATIONAL RAILWAY
TRAIN Q19771-09
MILE 48.41, SKEENA SUBDIVISION
KWINITSA, BRITISH COLUMBIA
15 NOVEMBER 2014**

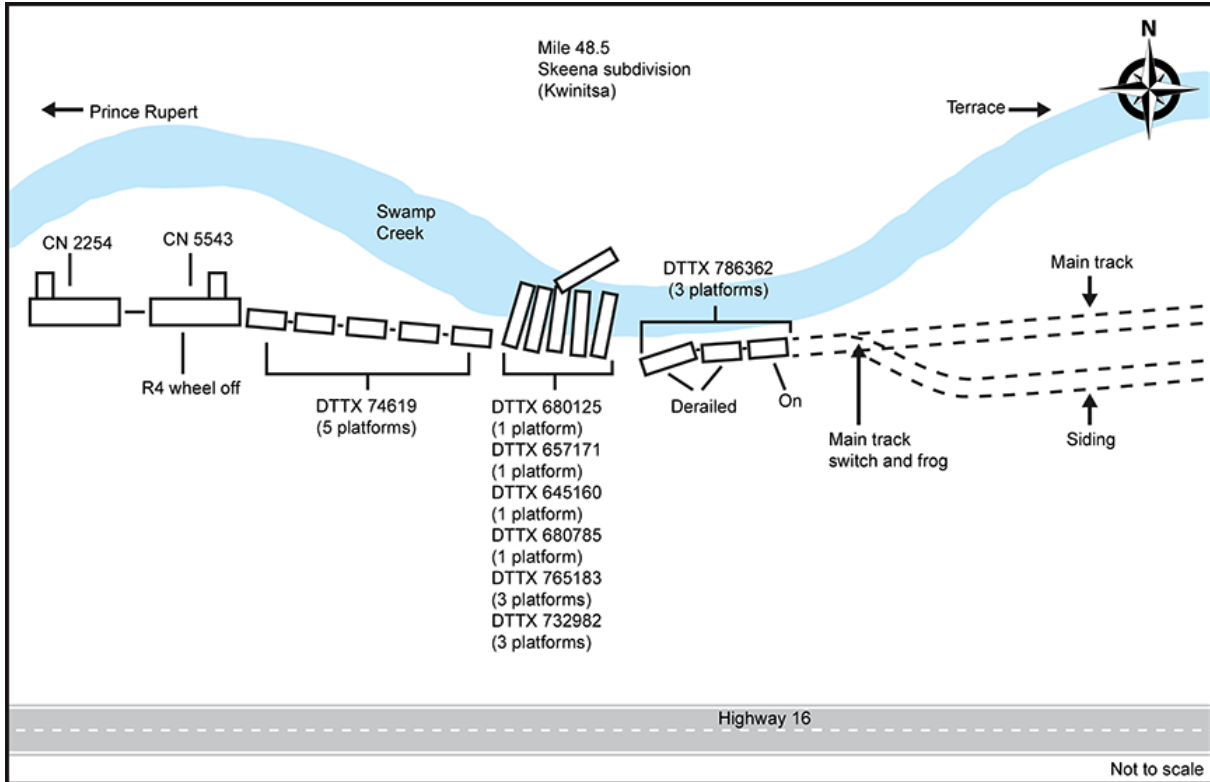
Figure 2. Sketch of derailment site

- The No. 4 axle of the trailing locomotive, CN 5543, was locked (i.e., not rotating) and the trailing locomotive and the first 8 cars had derailed (totalling 17 derailed platforms).
- The R4 wheel of the trailing locomotive had derailed to the gauge side of the south rail.
- The first car, DTTX 74619 (5 platforms), had derailed, but remained coupled to the locomotives. The next 6 cars had derailed in an accordion fashion to the north side and into Swamp Creek. The last derailed car, DTTX 786362 (3 platforms), had derailed 2 platforms, but remained upright (Figure 2).
- The north rail was broken mainly in the area where the intermodal cars derailed to the north side into the creek.
- West of the siding switch, the south rail had rolled or was displaced for approximately 300 feet.

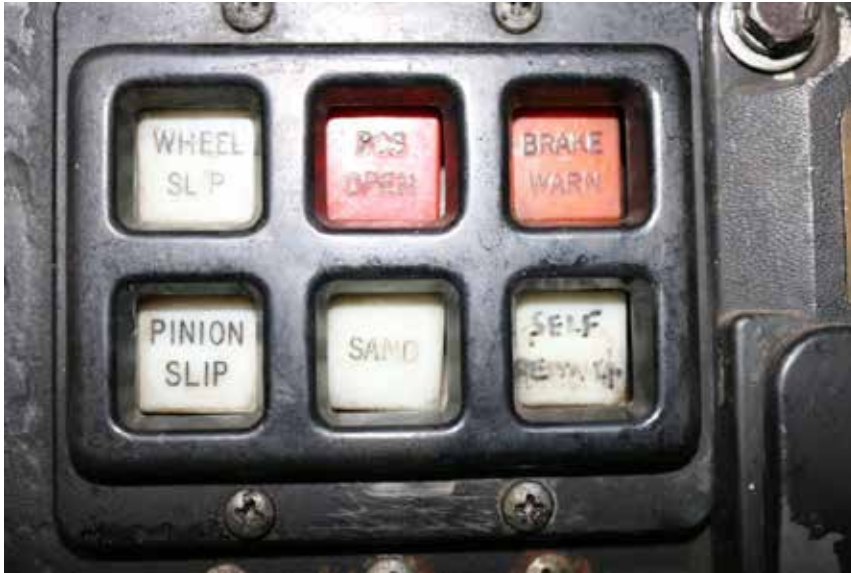
Photo 3. WHEEL SLIP indicator for SD60F locomotives

For the SD60F locomotive, its wheels and the relative power being consumed by the traction motors are continuously monitored. If there is an anomaly, a WHEEL SLIP indicator is generated. The WHEEL SLIP indicator is 1 of a group of 6 indicators on an overhead panel above the locomotive engineer position (Photo 3). The indicator is white with black text and is used to alert the crew to 5 possible wheel-related faults and a general Super Series failure.²¹

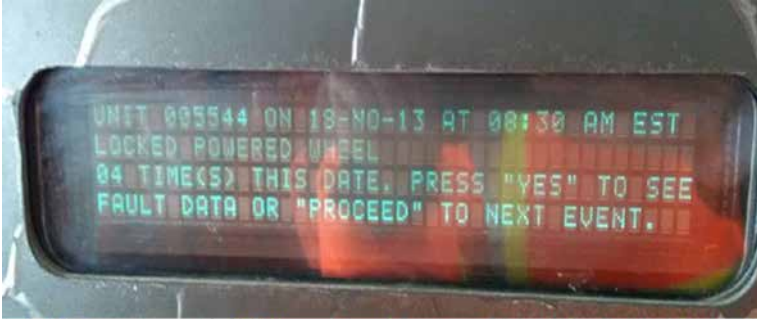
Photo 4. Human-machine interface display panel in SD60F locomotive
(Source: Canadian National Railway)

- Text**
 Urgent faults that required immediate action (faults 1 and 2) were accompanied by a computerized descriptive text. This text was presented on a panel behind the locomotive engineer. In the case of a locked powered wheel (locked axle), a text message indicating LOCKED POWERED WHEEL was presented on the human-machine interface display panel (Photo 4).
- Context**
 Faults can vary according to context (e.g., poor environmental conditions [fault 3] versus dynamic braking [fault 4] versus excessive speed [fault 5]).
- Cadence**
 Each fault had its own cadence on the visual display on the overhead panel. The different patterns included the following: lit continuously while powered; lit steadily or flash; occasional flash; intermittent flashing; flash on and off; and occasional and irregular flashing.

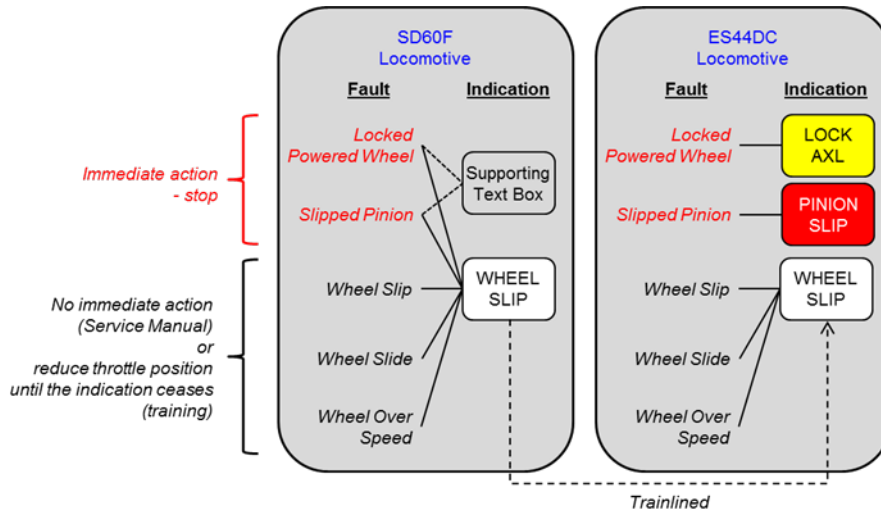
Figure 4. Indicators and their representations when an SD60F locomotive is trainlined with an ES44DC locomotive (lead position)

- If the fault was related to a wheel set on the ES44DC locomotive, the possible indicators were a yellow LOCK AXL text message, a red PINION SLIP text message, or a white WHEEL SLIP text message.
- If the fault (regardless of type) was related to a wheel set on the SD60F locomotive, only the white WHEEL SLIP text message was displayed, as all wheel-related faults for the SD60F locomotive were trainlined using this indicator (Figure 4).

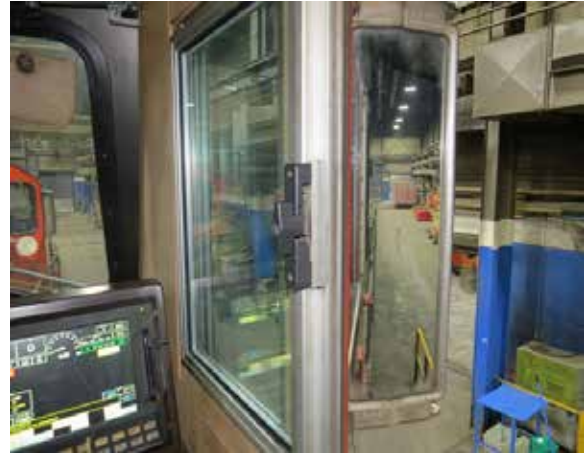
Photo 6. Locomotive engineer view in mirror

During this time, the skies were clear, but dark. There was a rear-view mirror on each side of the locomotive cab positioned such that the crew members could view toward the rear of the train without turning away from the forward-facing position (Photo 6). There was also a rear window on each side of the locomotive cab. By turning around, the train crew could use these rear windows to view the train behind them. However, the train crew’s view toward the rear of the train may have been obstructed by the following:
