# RAILWAY INVESTIGATION REPORT

## R15E0173

### **Non-main-track derailment**

Canadian Pacific Railway

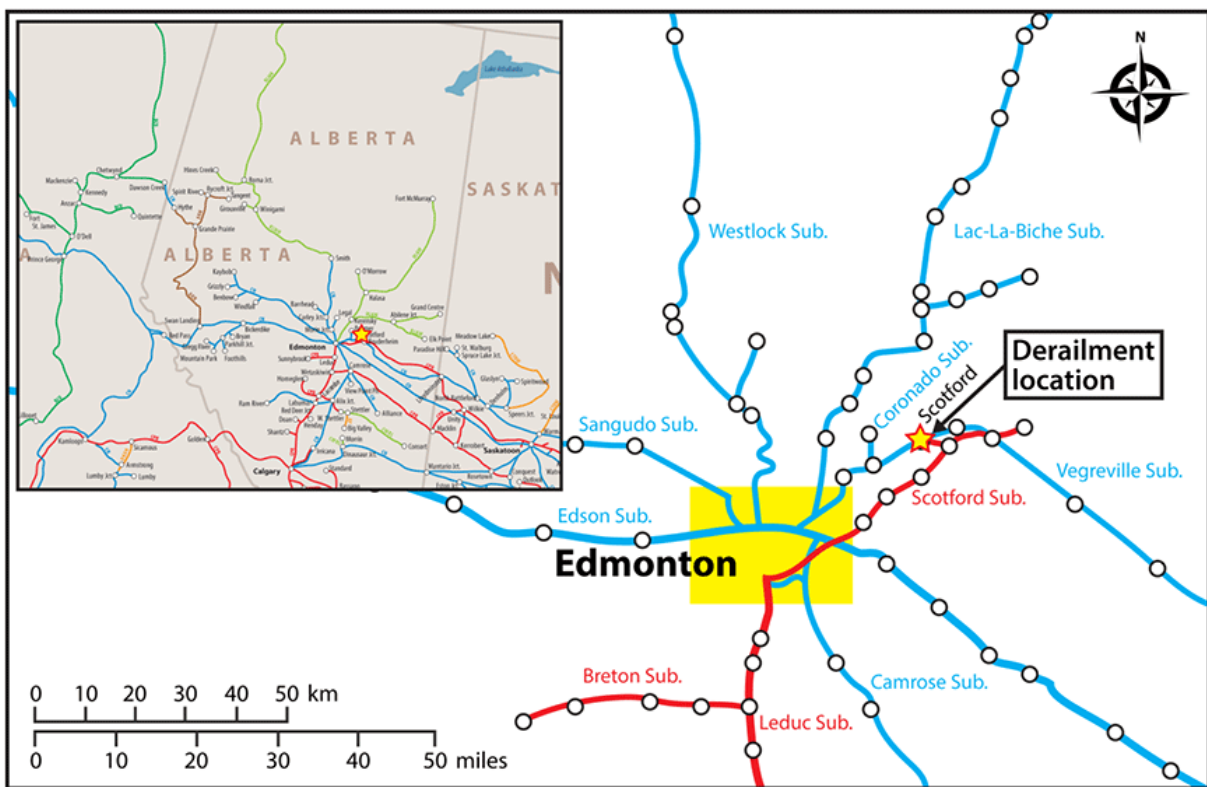
Figure 1. Derailment location (Source: Railway Association of Canada, *Canadian Rail Atlas*, with TSB annotations)

On 08 December 2015, switching assignment AS-01, which was being operated by a remote control locomotive system (RCLS), was working with 2 locomotives at the west end of Canadian Pacific Railway’s (CP) Scotford Yard in Scotford, Alberta (Figure 1). Scotford Yard is situated at Mile 138.1 on the Scotford Subdivision. The assignment, which originated at Scotford Yard, was servicing petrochemical companies in the local industrial area.

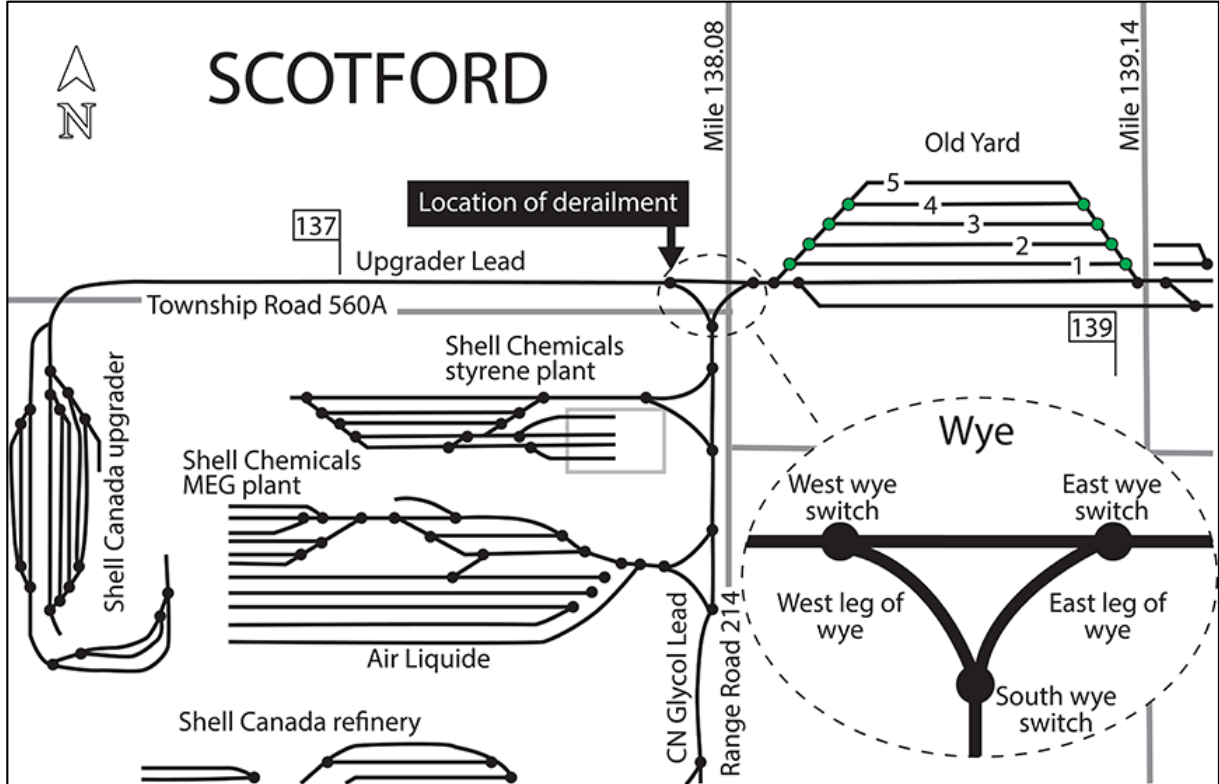
Figure 2. Scotford track layout

At the beginning of the shift, the crew, consisting of a yard foreman and a yardman, had operated the assignment westward with 22 cars from the Old Yard to service Shell Canada’s Scotford Upgrader (Figure 2). After servicing the upgrader, the assignment departed with 28 cars. On the return move, the crew decided to wye<sup>1</sup> the movement, which would reorient the locomotive consist so that the controlling locomotive faced westward, which was the orientation the crew was most familiar with.<sup>2</sup>

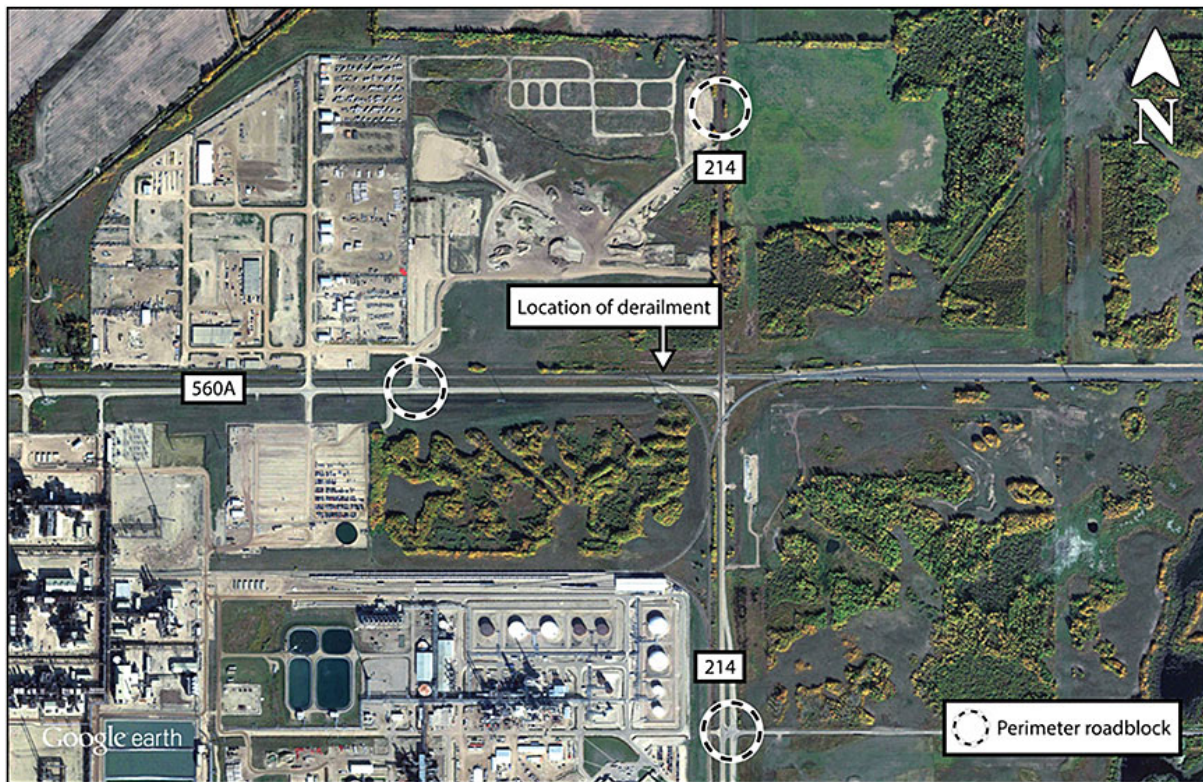
Figure 8. Location of derailment (Source: Google Earth, with TSB annotations)

Royal Canadian Mounted Police and Shell Canada security teams set up roadblocks at both ends of Range Road 214 and Township Road 560A to control access to the site (Figure 8). However, in the early hours of 09 December 2015, a television news team illegally gained access to the derailment site via Township Road 560A. The news team took some photographs and were removed from the site shortly after. Although they had entered the hot zone, the emergency phase of the response was over. The members of the news team did not report any ill effects from exposure to styrene monomer. There were no other unauthorized entries into the hot zone.
