RAILWAY INVESTIGATION REPORT

R15T0173

Non-main-track runaway, collision and derailment

Canadian National Railway Company

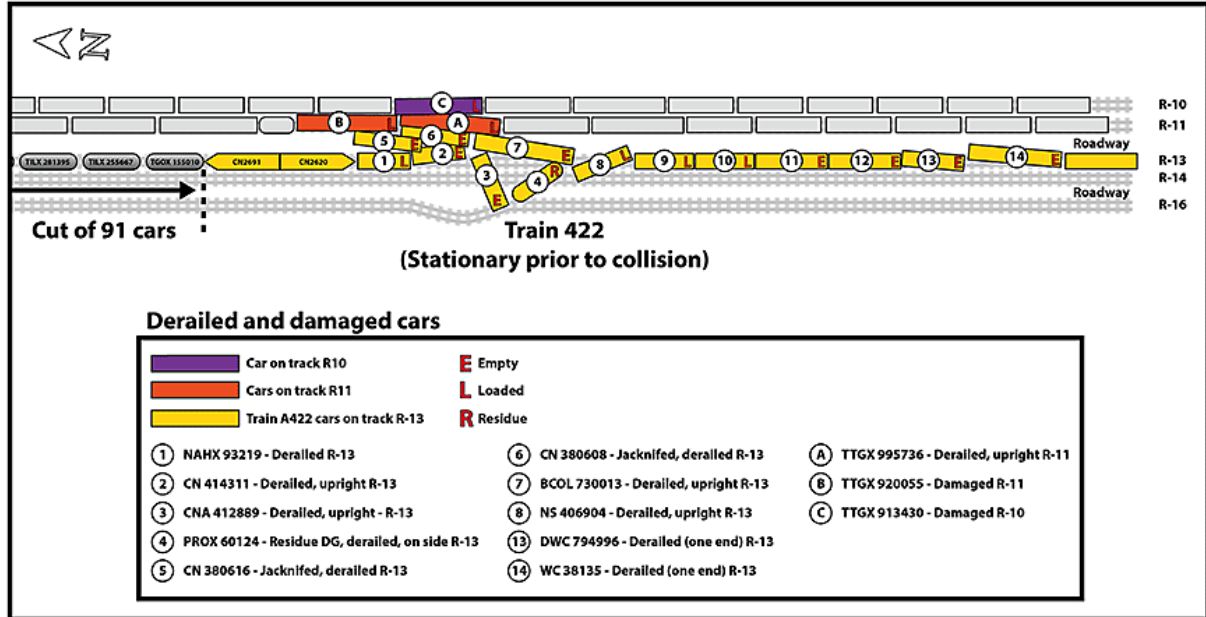
Figure 3. Site diagram

The collision occurred about 5900 feet south of switch 18. The force of the collision shoved both head-end locomotives on train 422 about 350 feet back onto its consist, resulting in the derailment of the 1st to 8th cars and the 13th and 14th cars behind the locomotives. The 3rd car (empty box car CNA 412889) diverged westward across track R-14 and a roadway, and displaced 60 feet of track R-16. The 5th and 6th cars (empty covered hopper cars CN 380616 and CN 380508) jackknifed vertically and then fell eastward and struck 2 loaded multi-level auto carrier cars (TTGX 920055 [damaged] and TTX 995736 [damaged and

derailed]) that were stationary on adjacent track R-11. Multi-level auto carrier car TTGX 913430 on track R-10 was also damaged. Six freight cars were destroyed. Approximately 585 feet (180 m) of track from tracks R-13, R-14 and R-16 was damaged (Figure 3). None of the cars of the uncontrolled cut of cars derailed.

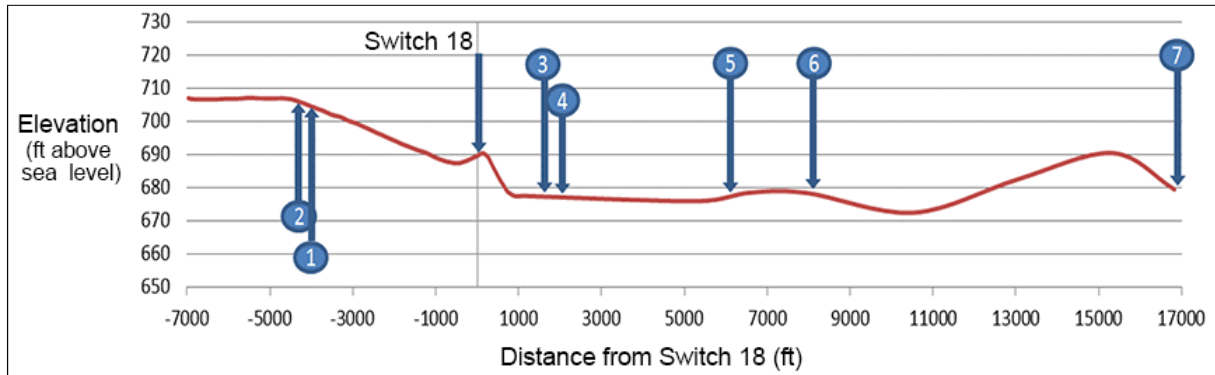
Figure 5. Track profile of route of the uncontrolled cut of cars with various critical points identified (not to scale)

A survey of the east pullback track, the east pullback lead track, track R-13, and the track up to and exiting the yard was reviewed. Using switch 18 as “zero,” various critical points related to the accident were measured. The resulting track profile (Figure 5) graphically illustrates the yard elevations, distances and critical points along the route of the uncontrolled cut of cars. The critical points coinciding with specific events or locations include

4. Northern limit of track R-13.
5. Point of collision with train 422, about 5900 feet south of switch 18.
6. Junction of track R-13 and the York 3 inbound track.
7. Junction of York 3 inbound track and York Subdivision main track.

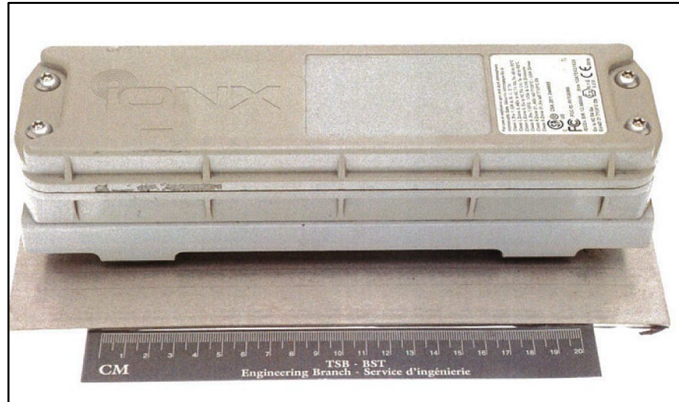
Figure 9. IONX data acquisition unit

Tank car TILX 281395 was also equipped with an IONX data acquisition unit (the unit) telemetry device. The unit was installed on the top centre of the tank near the manway entrance (Figure 9). The unit was recovered and sent to the TSB Engineering Laboratory to extract any available data from the unit in support of the investigation.

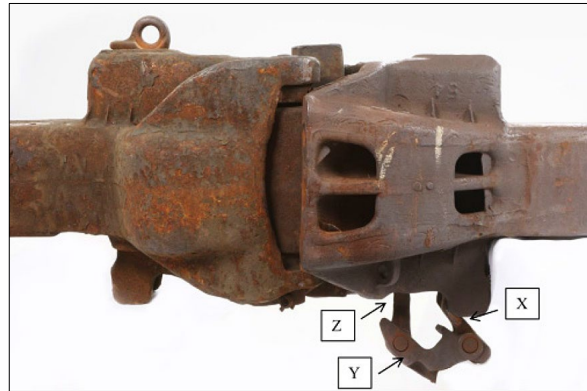
Figure 14. Lock-lift assembly installed detailing toggles X, Y, and Z

The lock-lift assembly consisted of 3 parts: toggle X, toggle Y and toggle Z. Toggle X sits on the trunnion at the bottom of the coupler body (Figure 14). Toggle Z engages

The lock-lift assembly exhibited extensive wear in the toggle joints and rivets when compared to a newer assembly (Figure 15). This extensive wear increased the lateral movement of toggle Z.

Anti-creep protection is provided to prevent unintentional uncoupling. An anti-creep test was performed on the coupler assembly in accordance with the AAR guidelines. The anti-creep protection functioned as intended. However, when closing the knuckle, the toggle Z pin of the lock-lift assembly occasionally jammed in the locking block hole, preventing the block from dropping into place (Figure 16).

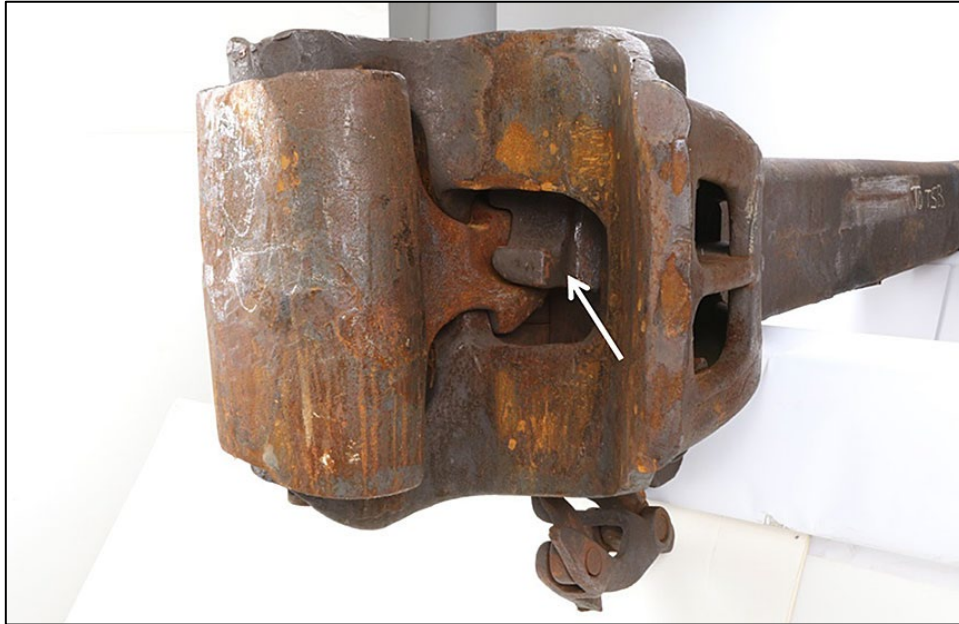
Figure 18. Locking block fully engaged

When the toggle Z pin of the lock-lift assembly jammed in the locking block hole, the locking block only partially engaged with the tail of the knuckle (Figure 17 and Figure 18).

Since the uncoupling lever hangs on 1 side of toggle Y, a side load is created in the lock-lift assembly during operation. Toggle Z displayed wear on the side and middle of the end pin that is inserted in the locking block hole in the tail of the block. The observed wear on the end pin of toggle Z was consistent with its interaction with the locking block hole and misalignment due to excessive lateral movement of the lock-lift assembly.

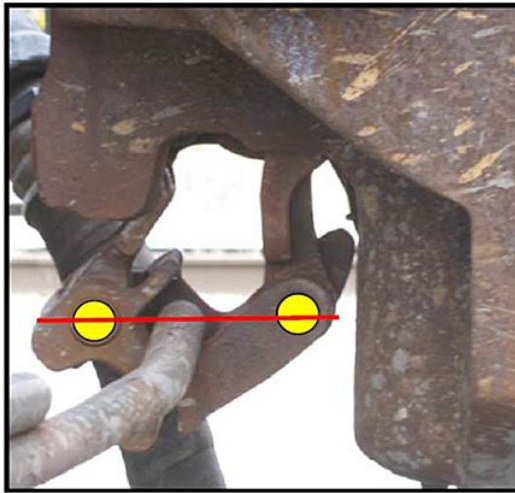
Figure 1: Properly seated pin

In 2014, CN had over 100 mainline cases where a knuckle opened up causing a train separation. This could happen when a lock block or “pin” has not properly seated.

A secure joint with a seated pin will look like Figure 1 where both of the pivot points are aligned parallel to the ground. A pin that is not secured looks like Figure 2.

1. When monitoring a joint look for this pattern to ensure the cars are securely coupled.
2. When performing a roll-by strive to ensure the lock-lift is in position (Fig 1).
3. Alert the crew when a pin is not secured to come to a controlled stop and then work the joint until it is secured.
4. When a coupler is not performing properly, ask mechanical staff for help to remedy the problem.
