RAILWAY INVESTIGATION REPORT

R16E0102

Main-track derailment

Mile 96.38, Grande Cache Subdivision
near Grande Cache, Alberta

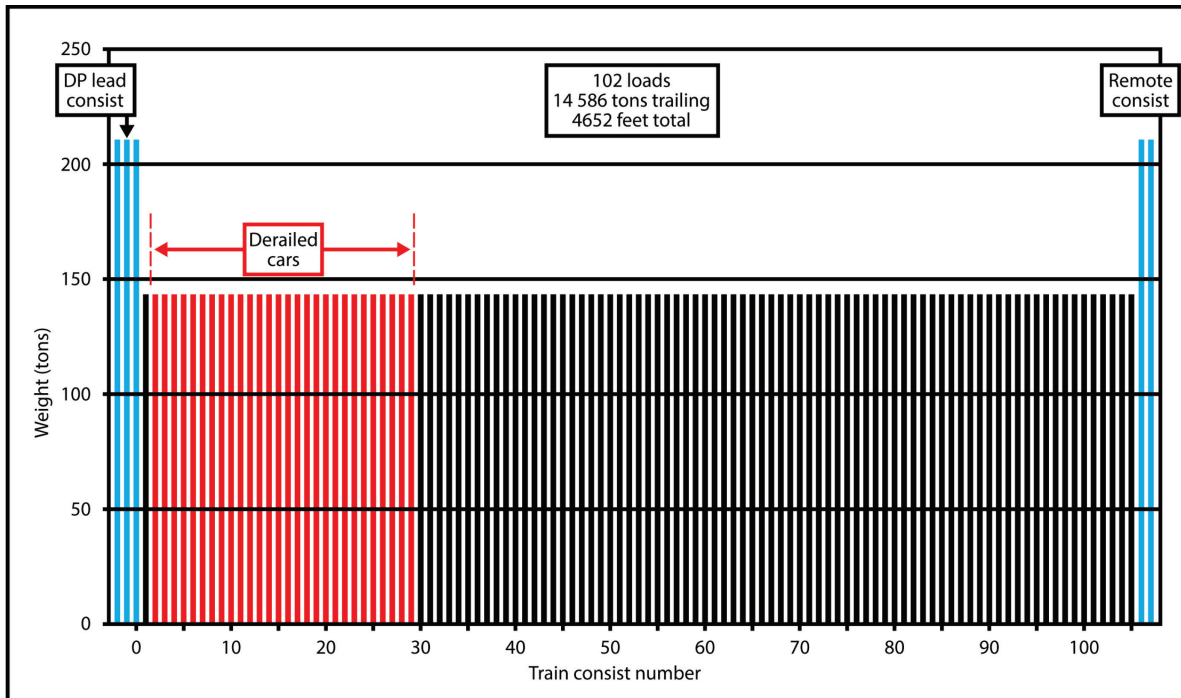
Figure 3. Weight profile for train

Each car in the unit train had been evenly loaded, and weighed about 142 tons (Figure 3).

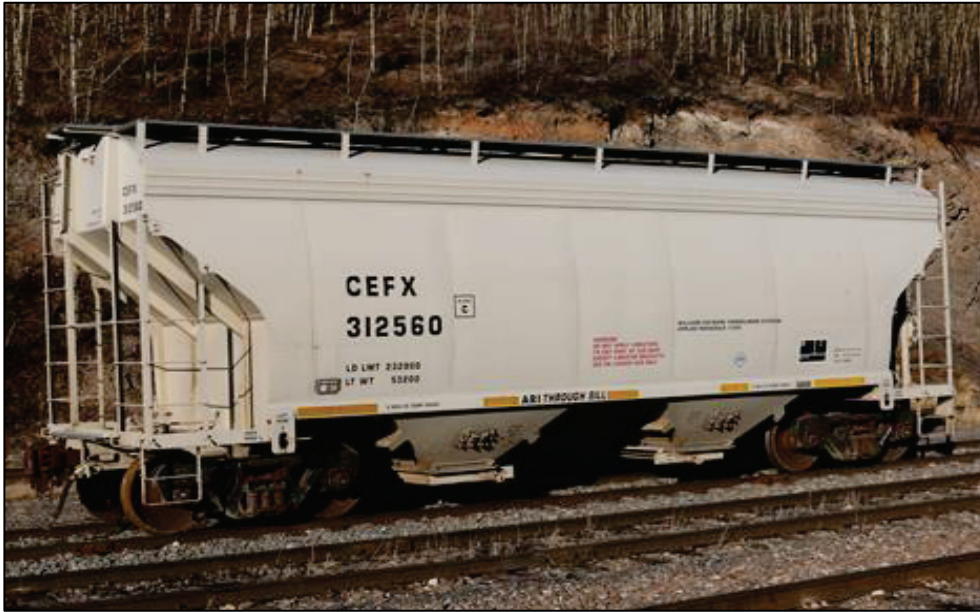
Figure 4. A typical 42-foot covered hopper car

All 102 cars of the train were 42-foot covered hopper cars (Figure 4) designed for hauling heavy, dense loads. The gross weight of each car was 286 000 pounds, with a load limit of 232 800 pounds. These cars are shorter than grain and coal hopper cars. However, when loaded with frac sand, these cars normally carry about the same load as the longer grain and coal hopper cars.

Longitudinal forces are not transformed into higher lateral forces on cars in the alignment position (i.e., on tangent track). However, for cars of the same weight, in some circumstances, shorter cars might exert higher forces on the rail in curves (i.e., unbalanced centrifugal L/V and/or transformed lateral forces in jackknifed position under buff in-train force) than longer cars.^{5,6}

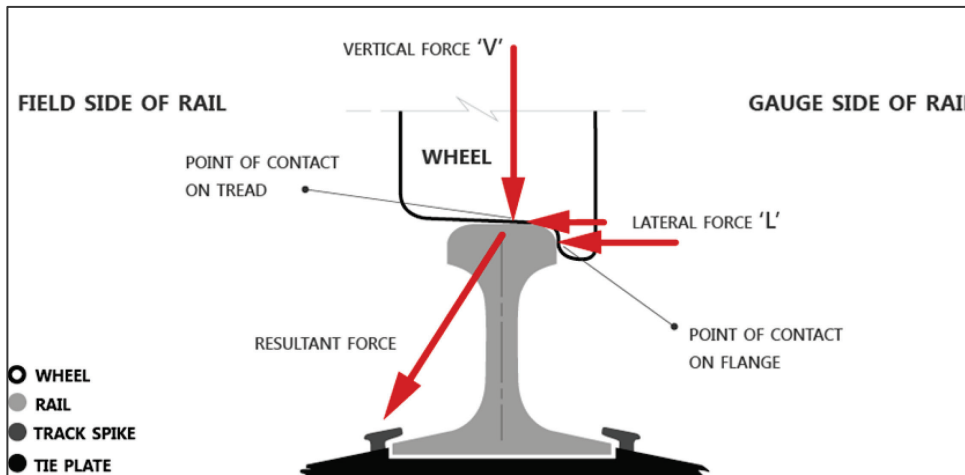
Figure 7. Lateral-to-vertical forces between wheel and rail (Source: Association of American Railroads, with TSB annotations)

A combination of lateral (L) and vertical (V) forces exist at the wheel/rail contact (Figure 7). The ratio of lateral-to-vertical (L/V) forces indicates the probability of a derailment: the probability of a derailment increases as the L/V ratio increases.

When a train is in compression or buff state, particularly in a jackknifed position in a curve, the drawbar angle can reach its maximum with the couplers pushing against the side of the housing. Longitudinal forces can be transformed into large lateral forces that can have an impact on the truck and be transmitted to the wheel flange on the high rail, canting and even rolling the rail over when the resultant force acts beyond the outer edge of the rail base. A high lateral force combined with a low vertical force (e.g., if the train has empty cars) can tend to push the wheel flange up and over the gauge face of the rail (wheel climb).
