RAILWAY INVESTIGATION REPORT R17H0015

Crossing collision

Canadian Pacific Railway

Colborne, Ontario

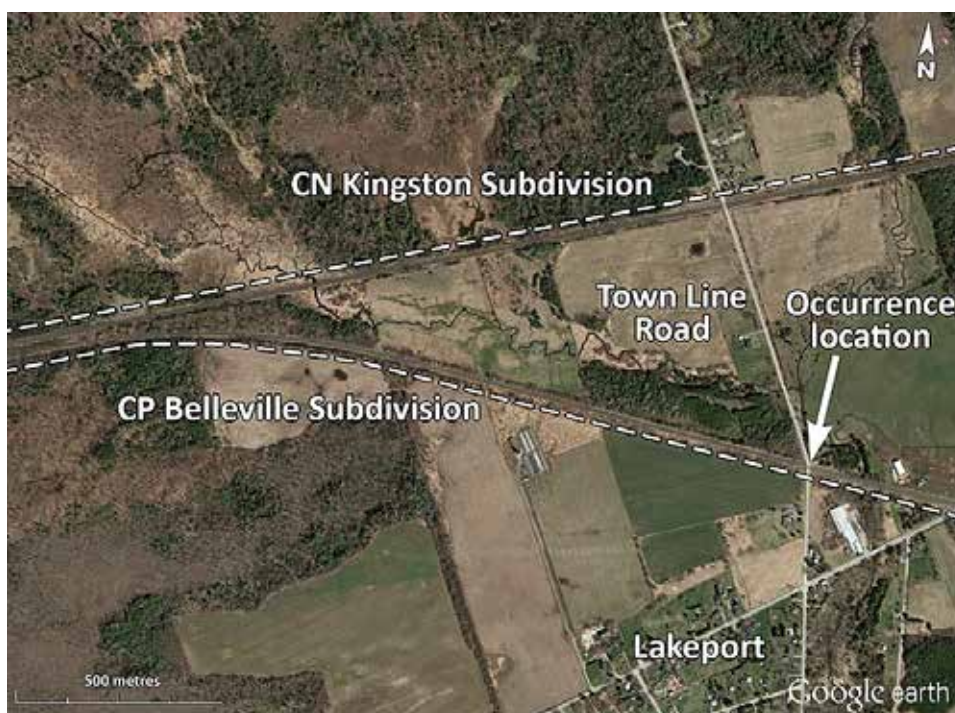
Figure 5. Occurrence location (Source: Google Earth, with TSB annotations)

In the vicinity of the crossing, the Belleville Subdivision is tangent and oriented in the east-west direction (Figure 5). The tangent track extends to the west for about 3000 feet, before it curves to the south. The timetable speed for freight trains was 50 mph. At the time of the occurrence, there were no temporary slow orders in the immediate area.
