RAILWAY INVESTIGATION REPORT

R17T0164

Main-track derailment

Canadian National Railway Company

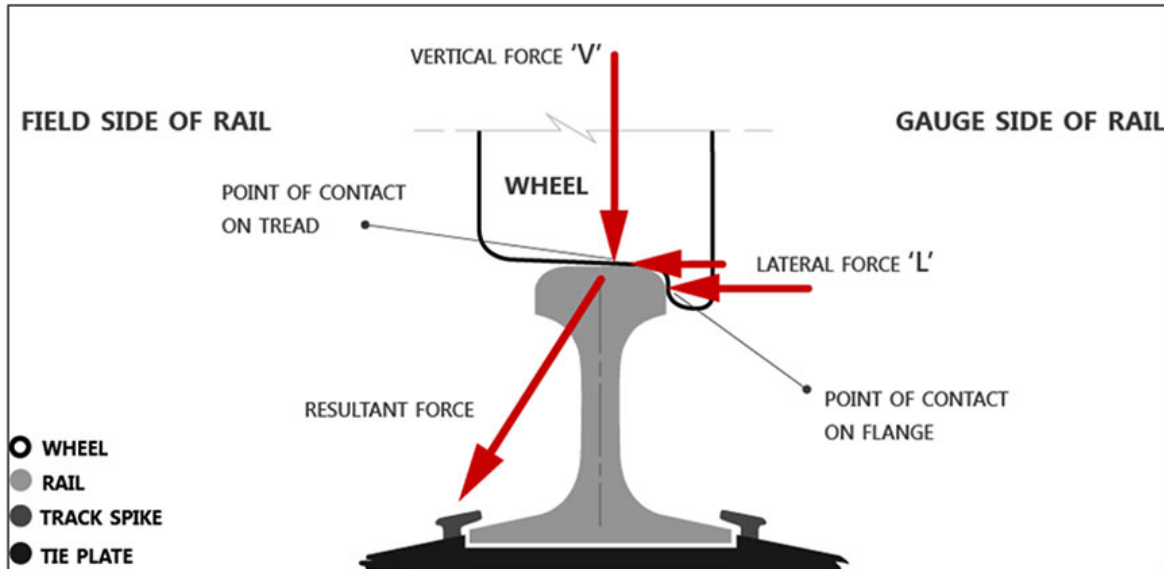
A combination of lateral (L) and vertical (V) forces exists where the wheel flange contacts the rail head (Figure 12). The ratio of lateral-to-vertical (L/V) forces indicates the probability of a derailment. The probability of a derailment increases as the L/V ratio increases. The highest L/V ratios typically occur when there is a sudden reduction in vertical load or a sudden increase in lateral load. A high lateral force combined with a low vertical force tends to push a wheel flange up and over the gauge face of the rail onto the rail head (wheel climb). A

wheel L/V ratio of between 0.80 and 0.90 of sufficient duration²³ is known to cause wheel climb.^{24,25}

Figure 12. Lateral-to-vertical forces between wheel and rail (Source: Association of American Railroads, with TSB annotations)
