RAIL TRANSPORTATION SAFETY INVESTIGATION REPORT R17V0096

NON-MAIN TRACK UNCONTROLLED MOVEMENT, COLLISION, AND DERAILMENT

Englewood Railway, Western Forest Products Inc.
Cut of cars
Woss, British Columbia
20 April 2017

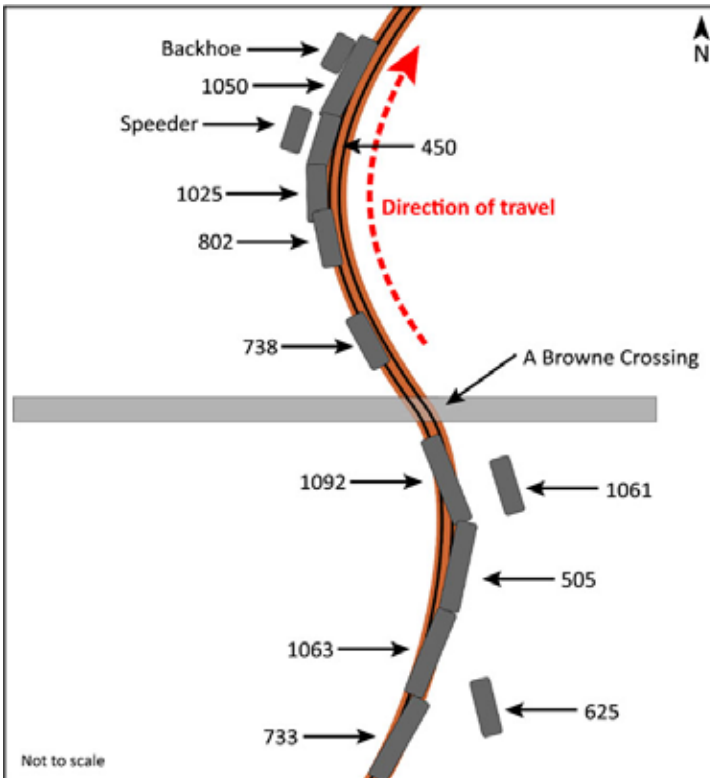
Figure 7. Positions of rail cars and engineering equipment at the derailment site

At the second derailment location, the remaining 4 cars, the speeder and the backhoe had derailed to the high side, in the body of the 14° right-hand curve. At this location, the track had shifted to the inside of the curve, which is consistent with cars tipping to the high side. The cars had lost their loads of logs, with some logs burying the backhoe and the speeder (Figure 9). The weight of the logs and the impact forces during the collision and derailment severely damaged the speeder and the backhoe.

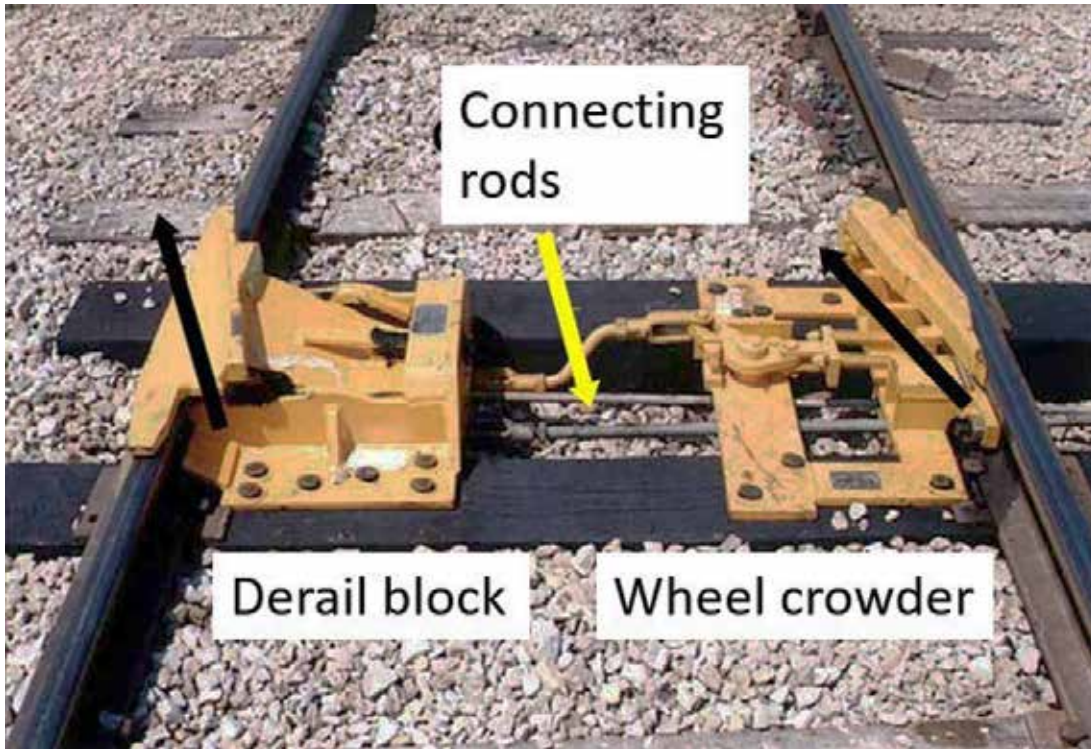
The derails installed on the Englewood Railway were Model HB sliding derails with a wheel crowder (Figure 12) manufactured by Western-Cullen-Hayes, Inc. With a wheel crowder installed, the flange of one wheel is “crowded” or pushed toward the derail block on the opposite side. The flange of the other wheel will strike and climb the derail block, move over the rail head, and drop onto the ties and ballast. This type of derail can be designed and configured to derail rolling stock to the right or to the left, depending on the specific needs at each particular installation.

The subject derail was configured to derail rolling stock to the right (in the direction of travel). The wheel crowder was on the left side, and the derail block was on the right side (Figure 13).

Figure 13. Exemplar of a sliding derail with a wheel crowder. Both appliances are operated by rods connected to a trackside operating stand.

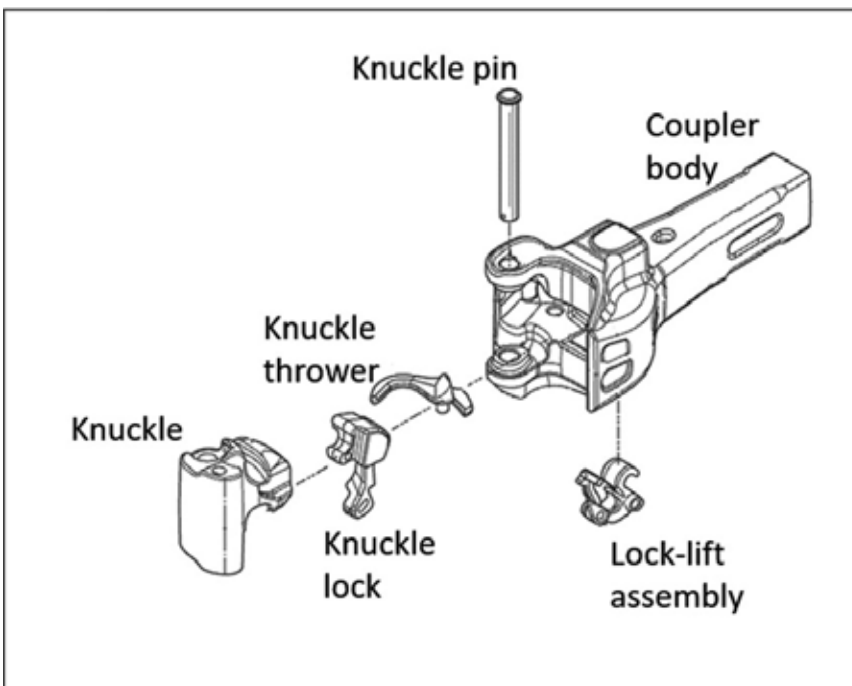
Figure 16. Diagram of Type E coupler components

The coupler from car 1043 was a bottom-operated, standard Type E coupler. It consisted of the coupler body, the knuckle, the knuckle lock, the knuckle thrower, the lock-lift assembly, and the knuckle pin (Figure 15). The coupler was manufactured in October 1981.

There were no markings stamped into the horn on the coupler body; this indicated that it had not been reconditioned. There was no cracking, no deformation, and no excessive wear present on the exterior of the coupler body. The coupler exceeded the minimum requirements for shank length and the dimension between the rear of the key slot and the shank butt.

As part of the laboratory examination, the coupler and its knuckle were inspected using gauges 25623-1 and 44057, as per the AAR guidelines. The contour of the knuckle and its fit in the coupler body were determined to be acceptable.³⁰ However, there was minor deformation with a fresh (not rusted) appearance present on the top edge of the knuckle tail (Figure 16).

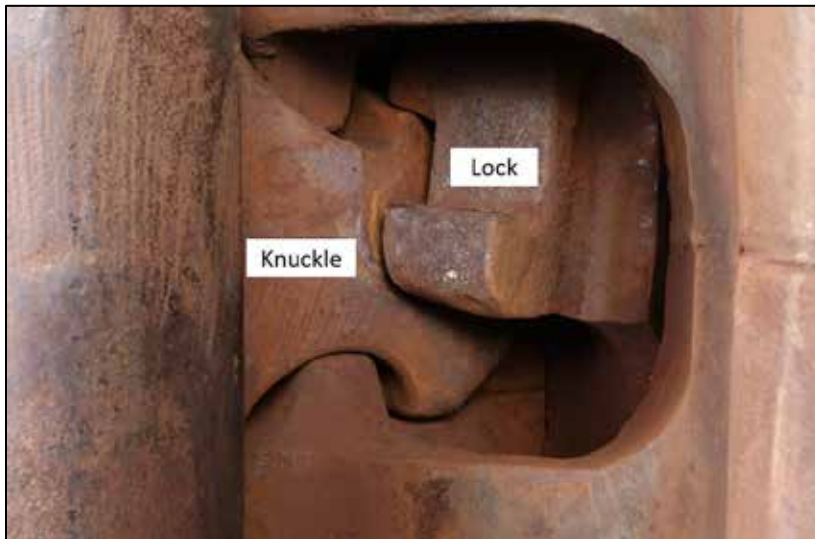
Figure 21. Subject coupler lock fully dropped and engaged with knuckle tail

The coupler operation with the original components installed was examined. When the knuckle was opened and the uncoupling lever was released, the subject lock rested on the top of the knuckle tail and on a positioning lug inside the coupler head (Figure 21). In this position, the subject lock was held up inside the coupler head with the lock set step above the top edge of the knuckle thrower. When the knuckle was closed, the lock dropped off the lug and onto the thrower in the lock set position (Figure 22).

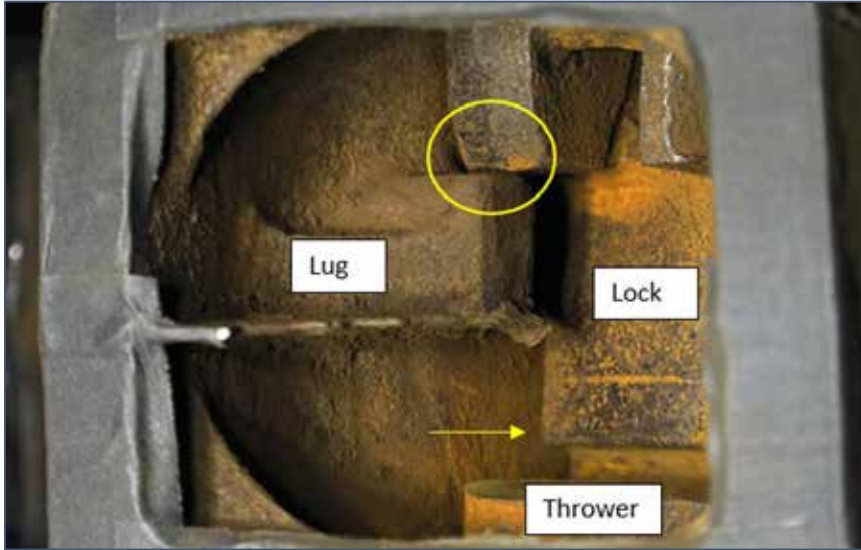
With the lock in the set position, partial interference occurred between the tail of the knuckle and the lock at the front. The radius and hardness of the lock contributed to the partial jamming of the knuckle such that the lock was not in the fully dropped and locked position. For the lock to drop off the set step and down to the fully dropped and locked position (Figure 23), it was necessary to open the knuckle a second time and to close it again.

Figure 22. Close-up of subject lock with the upper step resting on the positioning lug. Note that the set step on the lock is above the top edge of the knuckle thrower (indicated by the arrow).

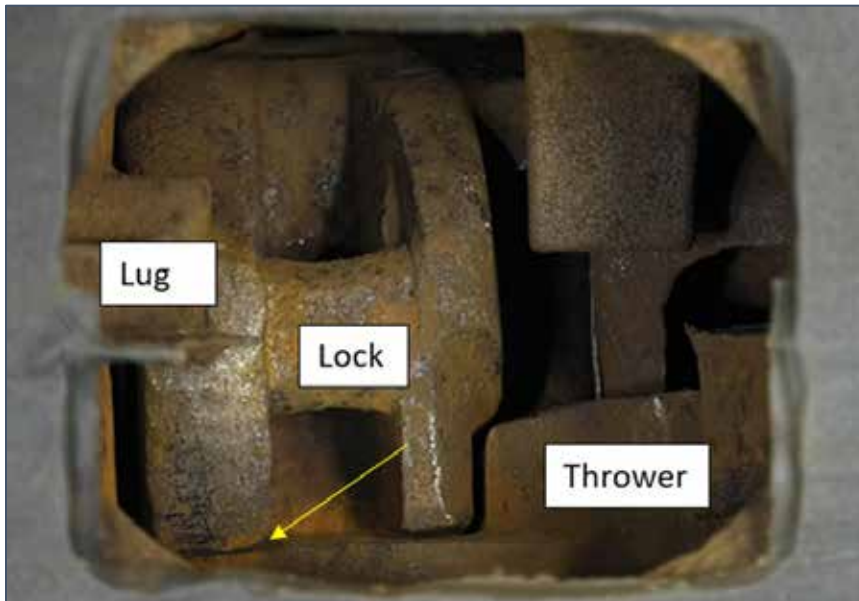
Figure 24. View of subject lock fully dropped and locked, sitting on knuckle thrower (arrow)

Several trials involving the operation of the coupler were conducted by successively changing out certain components. It was observed that, each time the subject lock was installed, the coupler did not operate as intended.

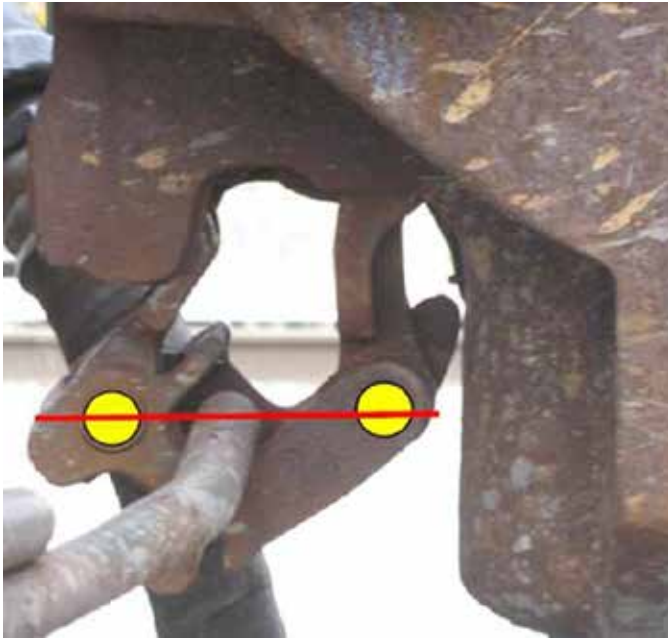
At least one Class I railway instructs operating crew members to visually inspect the coupling to ensure that the bottom-operated lock-lift assembly pivot points are properly aligned. When the coupler locking blocks have dropped properly into place to secure the knuckle, the pivot points will be horizontally aligned (Figure 24 and Figure 25). However, this indicator of a successful coupling was not widely known or circulated in training material throughout the railway industry at the time of the occurrence. Rather, general observation of the bottom lock-lift assembly to verify that the knuckle pin has dropped (i.e., the coupling was successful) has been a long-standing practice throughout the railway industry.

Figure 25. Proper alignment of the lock-lift assembly pivot points in a bottom-operated lock (locking block fully dropped)
(Source: Canadian National Railway Company)

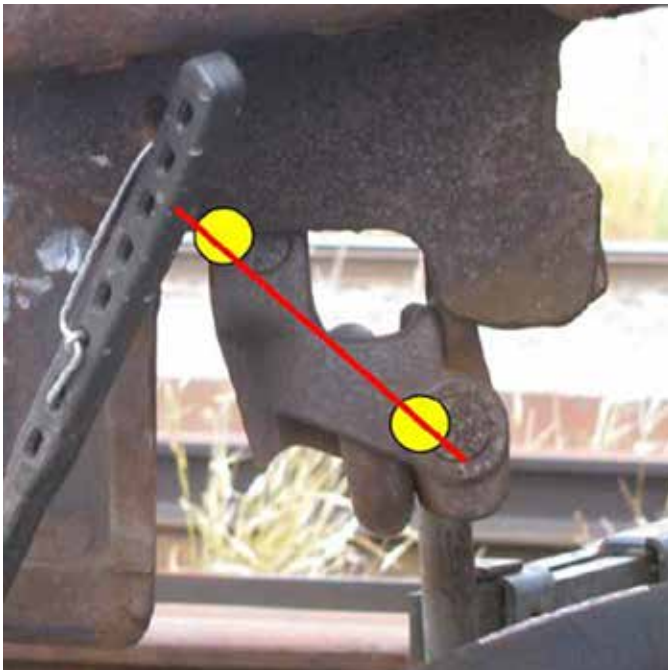
Figure 26. Misalignment of the lock-lift assembly pivot points in a bottom-operated lock (locking block not fully dropped)
(Source: Canadian National Railway Company)

For the type of coupler in this occurrence (bottom-operated), a visual confirmation can be performed by looking for proper alignment of the bottom-operated lock-lift assembly pivot points (Figure 24 and Figure 25). If the pivot points are not aligned, the locking blocks do not drop fully into place and the coupling is not secured. However, it was determined that some head loaders, including the one in this occurrence, were not aware of this visual confirmation technique.
