Rail Transportation Safety Investigation Report R18D0020

CROSSING COLLISION

Track unit PNR 728

Mile 12.15, Canadian Pacific Railway Vaudreuil Subdivision

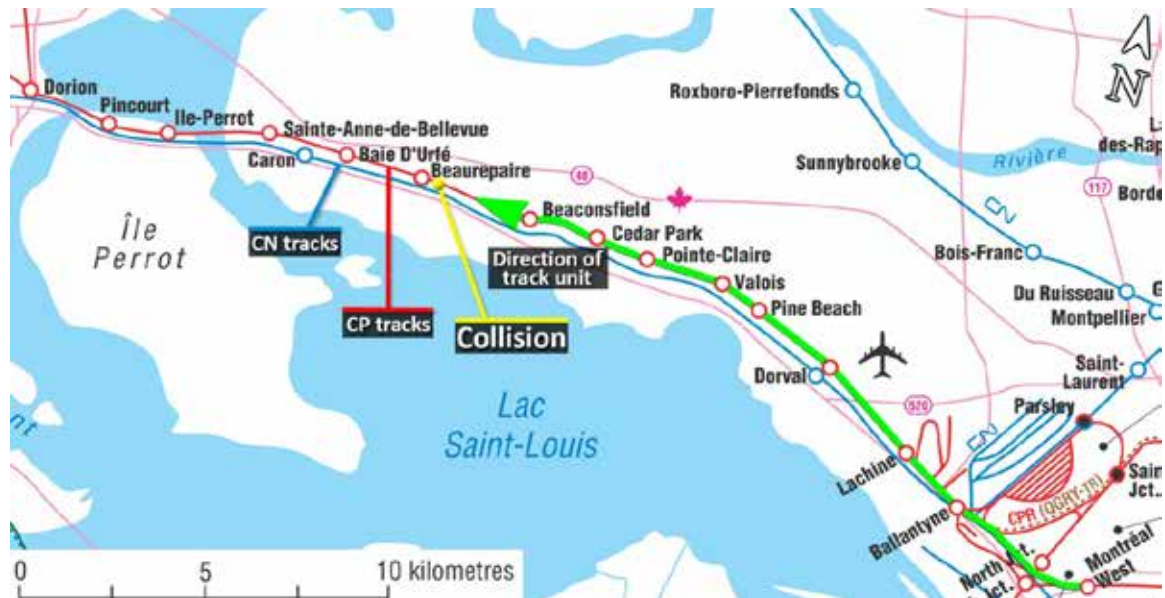
Figure 2. Collision area (Source: Railway Association of Canada, Canadian Railway Atlas, with TSB annotations)

At about 1440, the TU was travelling westward at approximately 20 mph when it approached the Woodland Avenue public crossing in Beaconsfield, Quebec, located at Mile 12.15 (Figure 2). When the TU was approximately 200 feet east of the crossing, the foreman advised the operator that the TU was approaching a crossing, as previously agreed. As the TU slowed, the operator noticed road vehicles moving at the crossing. He applied the emergency brake and lowered the snow plow to force the TU to slow down. The TU was unable to stop before it reached the crossing and it struck the rear end of a road vehicle.
