RAILWAY INVESTIGATION REPORT

R99T0031

DERAILMENT

Canadian National
Train No. CN M-304-41-05
Mile 255.1, Ruel Subdivision
Neswabin, Ontario
06 February 1999

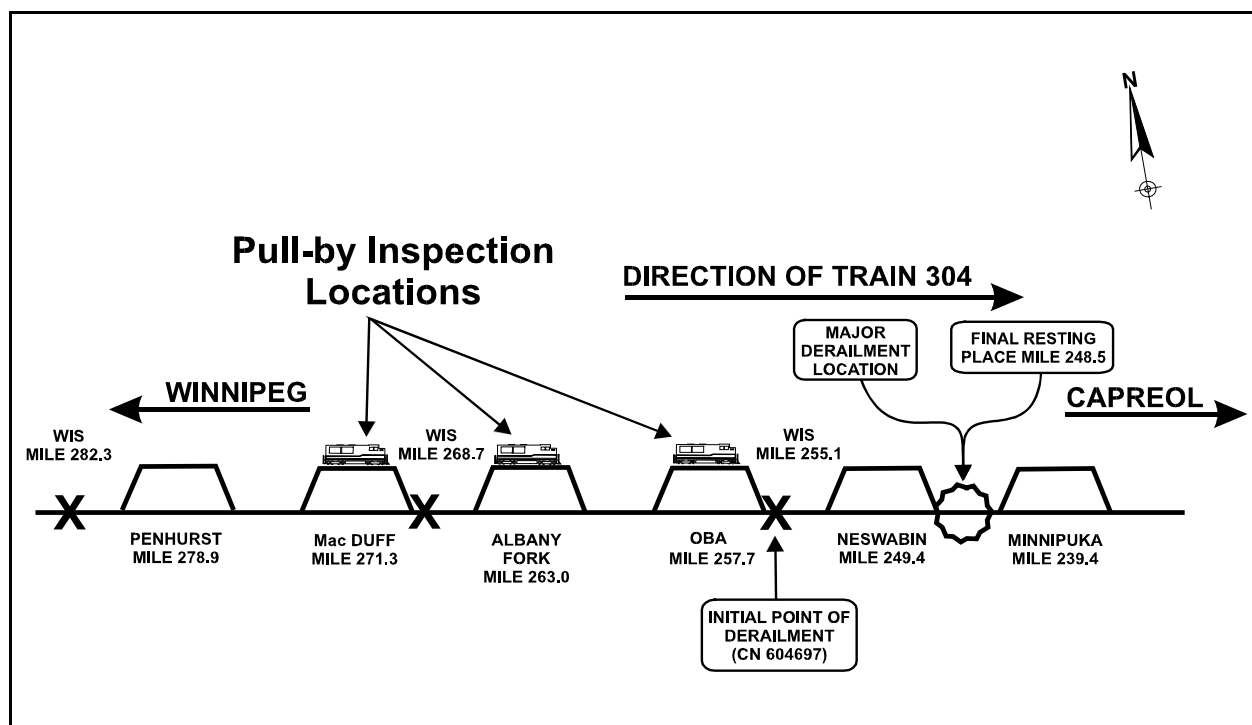
Figure 5 - Simplified Sketch Showing Pull-by Inspection and WIS Locations Relative to the Accident
Location 11

Between the initial terminal of Hornepayne and the point of derailment, a distance of approximately 41 miles, train 304 had been inspected by the crew members of three other trains that were passed at the three sidings preceding the point of derailment (see Figure 5). Train 304 was inspected on the north side only at these three locations. Due to heavy snow conditions, there were few safe areas for employees to position themselves to inspect a passing train on the south side. No defects were noted during these inspections.

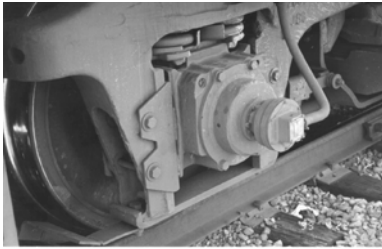
Figure 16 - Side views of locomotive roller bearing housing
(Note: bottom tie strap under bearing)

Both Southern Technologies Corporation (STC)¹³ and Harmon Industries¹⁴, the two major suppliers of HBDs in North America, stated that, even in favourable environmental conditions, some bearings on locomotives cannot be accurately scanned. The HBD functions as intended; however, there are mechanical parts located between the bearing and the scanner which can obscure the view of the bearing as it passes the HBD (see Figures 16 and 17). These mechanical parts differ by axle size and by locomotive type. Locomotives represent a small percentage of all axles scanned; however, unlike freight equipment, many locomotives are manned.

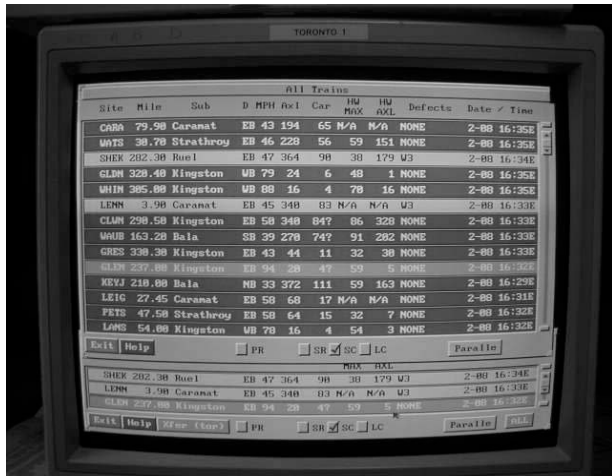
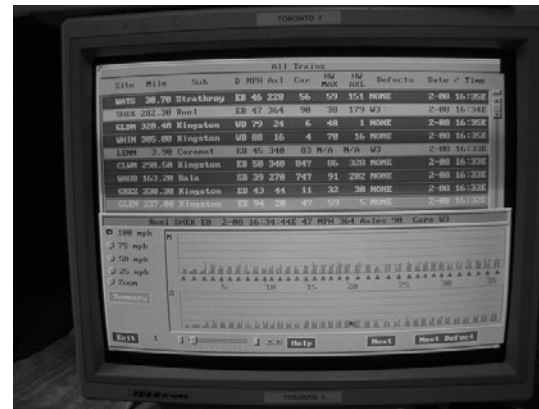
Figure 19 - Actual computer screen displays used by HBOs and RTC Mechs
 (Note electronic version of analog tape displayed on the bottom of the screen on the right)

A train is not normally displayed on the screen in its entirety (e.g. typically 35 cars to a display screen) because of the size of the analog tape. In order to view the complete tape, the HBO must scroll from one direction to another (see Figure 19). When the “high” reading is identified, the operator can obtain more detailed information by clicking on the relevant portion of the tape. Once the tape is examined, the operator has a choice of either acknowledging having viewed and interpreted the tape or placing the tape back into the queue for later reference.

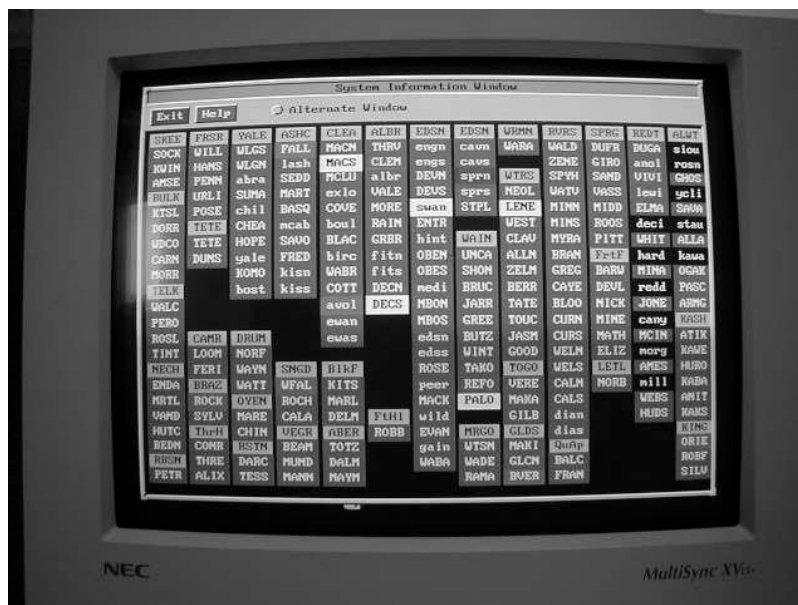
Figure 22 - Actual Screen Display Used by HBOs and RTC Mechs to Monitor the Status
of Some of the WIS Sites 30

In the month preceding the occurrence, the Edmonton office acquired responsibility for monitoring the sites previously monitored in Toronto and Montréal. The number of sites handled by the Edmonton office increased from approximately 200 to 400. Management indicated that, for a period of time before the centralization of the WIS data, the RTC Mechs attempted to monitor and track trains which showed signs of potential bearing failure. During this trial, they found that it was very difficult to accomplish this while also performing their other duties.

Figure 22 illustrates one of the three monitors in the Edmonton office showing the status of the WIS sites. Each rectangular box represents one WIS site and in total nearly 200 sites are monitored on this screen. Different colours are used to convey information about each site, such as a scan in progress, a site under repair, or a loss of data communication.
