AVIATION INVESTIGATION REPORT

A01C0152

COLLISION WITH POWER LINE

DE HAVILLAND DHC-2 BEAVER (SEAPLANE) C-FNFO

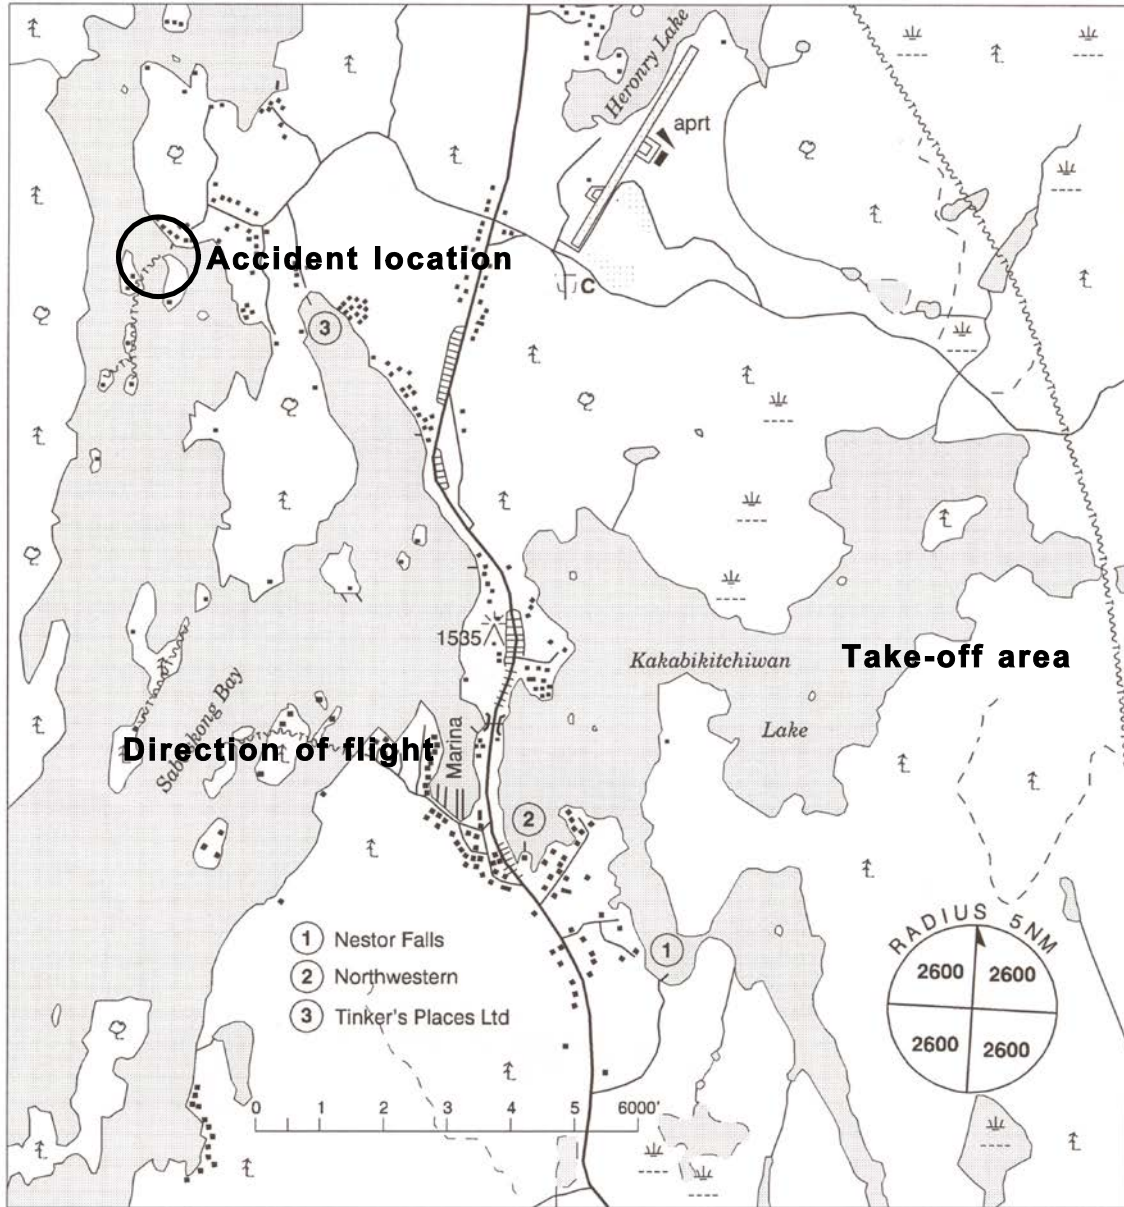
Appendix A—Nestor Falls Area Chart

NESTOR FALLS ON

Although the power line was depicted on the chart in the WAS, and the pilot had been briefed about the hazard presented by power lines in the company's area of operations, it was not determined whether the pilot knew the location of this specific power line.
