AVIATION INVESTIGATION REPORT

A97P0303

FLIGHT CONTROL SYSTEM MALFUNCTION

BOEING VERTOL BV-234 (HELICOPTER) C-FHFH

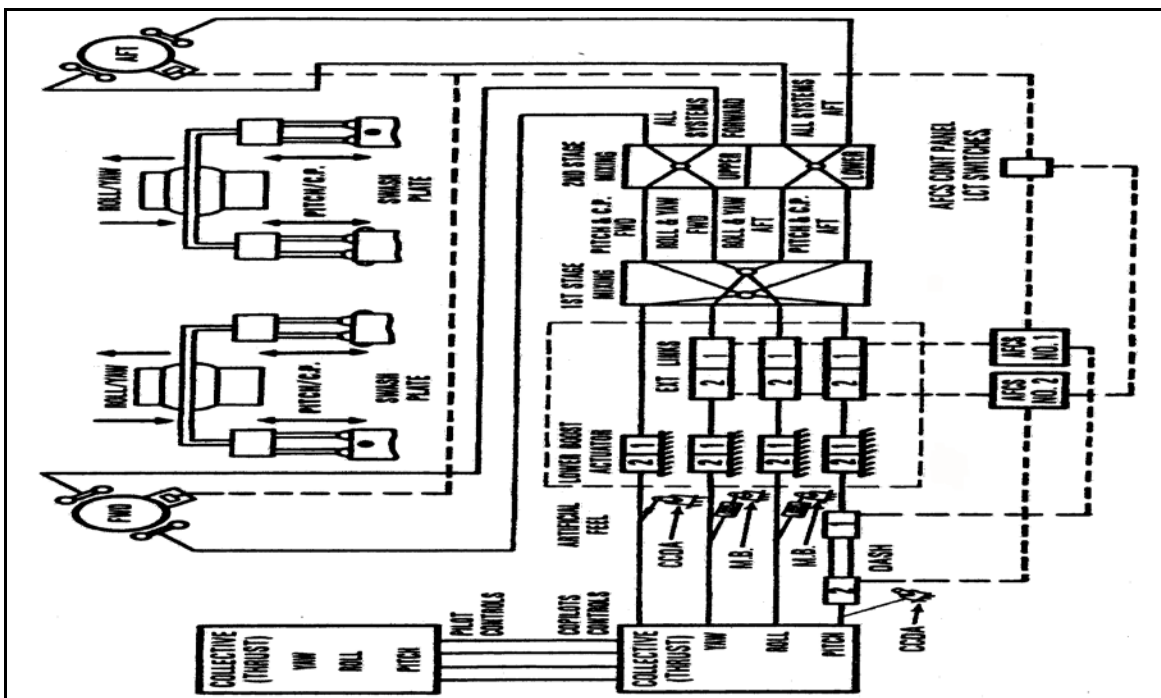
Actuators powered by the hydraulic systems are of three basic types: dual upper boost actuators (UBAs) for eliminating rotor loads from the control systems; dual lower stick-boost actuators (LBAs) for eliminating control weight and friction forces; and dual extensible link actuators (ELAs) to provide automatic flight control system (AFCS) inputs to the mechanical flight control system. There are four LBAs, one each for the pitch, roll, and yaw axes, and one for thrust (or collective), and three ELAs, one each for the pitch, roll, and yaw axes.

Pressurized fluid flows from the tanks to the flight control pumps and to the actuators; return fluid from the actuators flows back to the tanks. Each system provides hydraulic pressure to operate the two UBAs in both the forward and aft pylons, the three ELAs, and the four LBAs. Since each actuator is a dual element, the flight

controls can be operated on a single system; however, it is impossible to control the helicopter without hydraulic system power.

The yaw LBA (part number 234HS560-3 / serial number 0053V) had accumulated 5443 hours total time since new and consists of two separate actuators—the upper and the lower units. The upper actuator is supplied with hydraulic pressure from the No.2 hydraulic system, and the lower actuator is supplied by the No.1 hydraulic system. Each unit is designated by its respective hydraulic system. The seal around the actuating rod in the No.1 (lower) yaw LBA was found extruded from around the rod, and functional bench-testing revealed a slight leak from the broken seal. Functional testing also revealed that the No.2 yaw LBA would not maintain hydraulic pressure, and a rupture about one inch long was found in the cylinder wall. The actuator was then examined by three independent laboratories to determine the mode of failure and to identify the actuator material.
