Aviation Occurrence Report

Collision with Terrain

Cessna 180K C-GIGK
Aux Mélézes River, Quebec
10 August 1997

Report Number A97Q0168

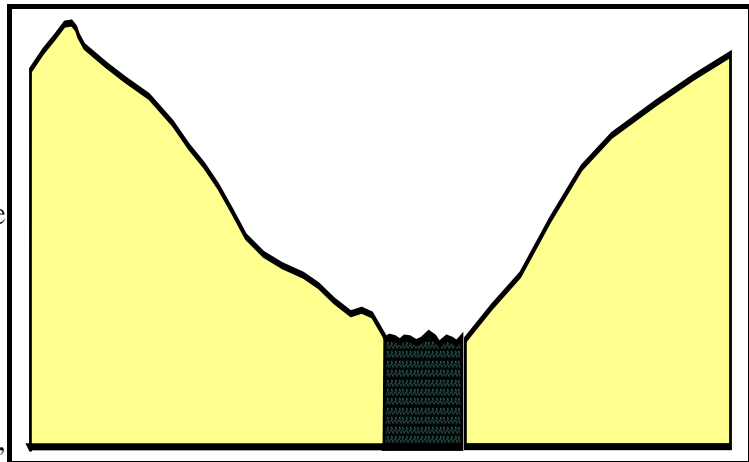
During the flight, the pilots communicated with each other on a common VHF frequency. C-GIGK was a few miles ahead of CF-RHI at an approximate altitude of 1,000 feet asl. After finding a spot he considered suitable, just upstream from some rapids, the pilot of C-GIGK relayed the information to the other pilot so the latter could make an inspection overflight of the site. The pilot of CF-RHI overflew the suggested location, then made a water landing with no difficulty. A short time later, the pilot of C-GIGK initiated a final

approach to land at the same spot, but before touchdown, the pilot initiated a missed water landing procedure. He then informed the pilot of CF-RHI that he was going to inspect more carefully the landing area. He had decided to fly another circuit because he was unsure of the strength of the current in the river. After advising the pilot of CF-RHI of his intentions, the pilot of C-GIGK did a go-around over the river to about 450 feet above ground level, followed by a 90-degree left turn to join the cross-wind leg. The aircraft levelled off and proceeded toward the south slope of the valley. About 30 seconds later, as C-GIGK had not yet turned parallel to the river and the upward-sloping terrain, for the downwind leg, and the seaplane was getting close to the rising terrain, the pilot of CF-RHI advised the pilot of C-GIGK to watch out for the mountain. A few seconds later, the aircraft pitched up without changing heading, then made two turns; the first turn was at a low bank angle to the right, upwind, and the second turn was steep and to the left, downwind. The aircraft started to lose altitude and pitched up gradually until it struck the trees, then struck the ground in a nose-down attitude. Four or five seconds after the impact, a fire started on the right side of the cabin. Thirty to sixty seconds elapsed

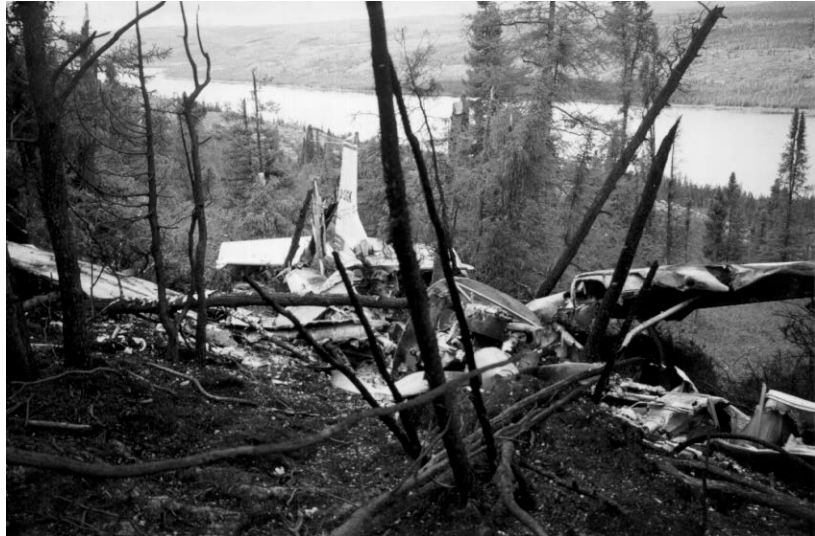
The accident occurred around 1330, during daylight, at 100 nautical miles southwest of Kuujuaq, Quebec, in a partially wooded area approximately half a mile south of the aux Mèlèzes River. The area is somewhat rough, with trees, mainly larch, of average size. The south side of the valley slopes upward at an angle of almost 20 degrees. The aircraft came to rest about 450 feet above the valley floor. The aircraft cut several trees over a distance of 50 feet before striking the ground.

Based on the cut trees and the damage to the wings, the seaplane had a left roll attitude of 15 to 20 degrees, was nose-down, and on a heading of 113 degrees magnetic when it struck the ground. The damage attributable to the impact and the nose-down attitude of the wreck are consistent with a loss of control following a stall.

The aircraft appeared to be relatively intact right after the crash. The wings were still attached to the airframe; however, the aircraft was destroyed by the fire that started shortly after the ground impact. The fire spread to the vegetation over a distance of 40 feet in front of the aircraft. All of the fuselage, except the empennage and part of the left wing, was consumed by fire. The right side of the aircraft appears to have sustained the most damage from heat. The lock of the pilot door was engaged, but the passenger door lock was not recovered. The fuel selector switch was on "BOTH". The wings were burned in the area of the integral fuel tanks. A tree broke through the spar and underside of the right wing near the integral fuel tank and wing attachment bracket. The flaps were extended at 20 degrees. On a Cessna 180K, this is the flap setting normally used for a go-around.
