Air Transportation Safety Investigation Report A18W0081

BAGGAGE COMPARTMENT FIRE

WestJet
Boeing 737-700, C-GWJT
Calgary, Alberta
14 June 2018

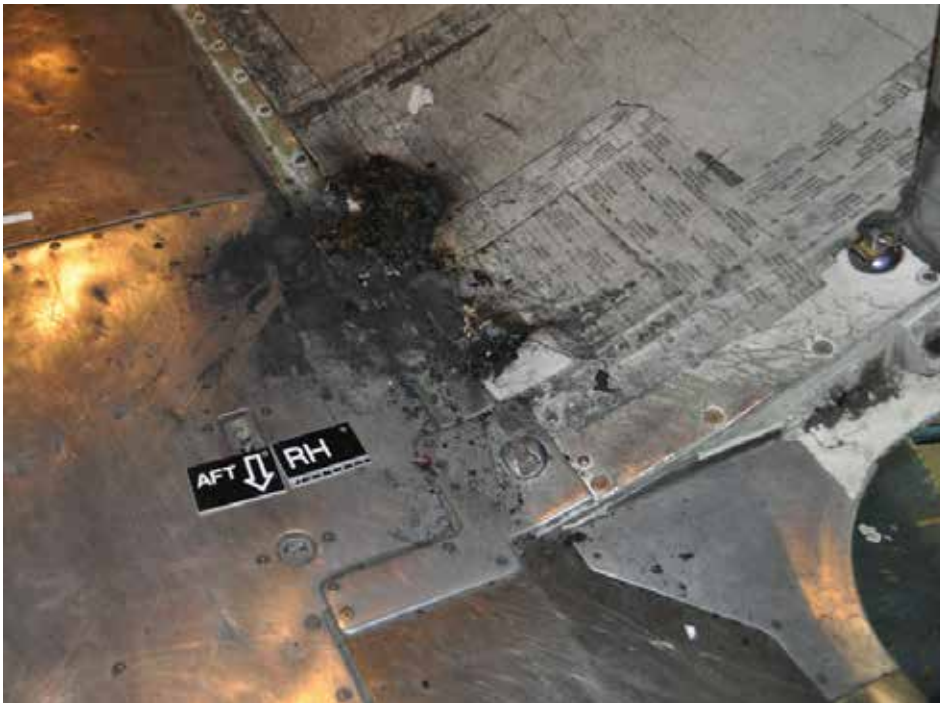
Figure 2. Fire damage to lower aft cargo compartment

The fire damage was isolated to the individual bag.

Minor thermal damage was found to the cargo compartment's fire-resistant liner near the bag. The fire did not penetrate the cargo liner or aluminum floor structure and was contained to an area of approximately 24 inches by 24 inches (Figure 2). There was no additional damage to any of the surrounding bags. The burnt bag was offloaded and segregated, and then all other passenger baggage were offloaded.

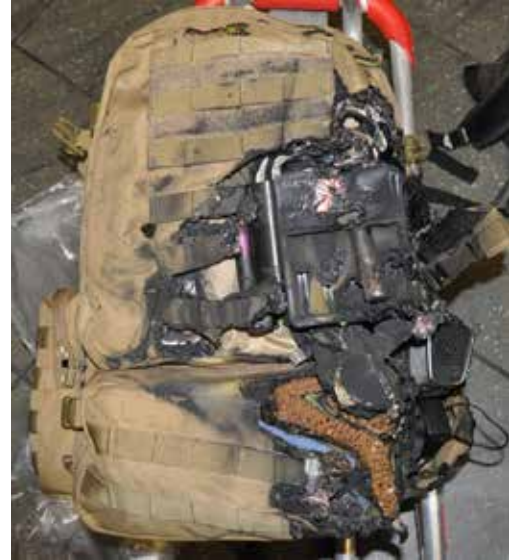
Figure 1. Passenger bag showing fire damage

One passenger bag, found face-down near the cargo compartment door opening, showed signs of fire damage (Figure 1).

The engineering report concluded that 1 battery in the charger experienced a thermal runaway and the interior material of the battery was completely burnt out. The thermal runaway was likely caused by external damage. The investigation could not determine if the damage occurred before the battery arrived at the airport or during baggage handling.
